**ANNA MARIA ISLAND  
Inspection Report  
Inspection**

**Structure ID: Anna Maria Island City Pier  
DISTRICT: D1 - Bartow**

**INSPECTION DATE: 12/30/2024**

TYPE OF INSPECTION: Regular NBI

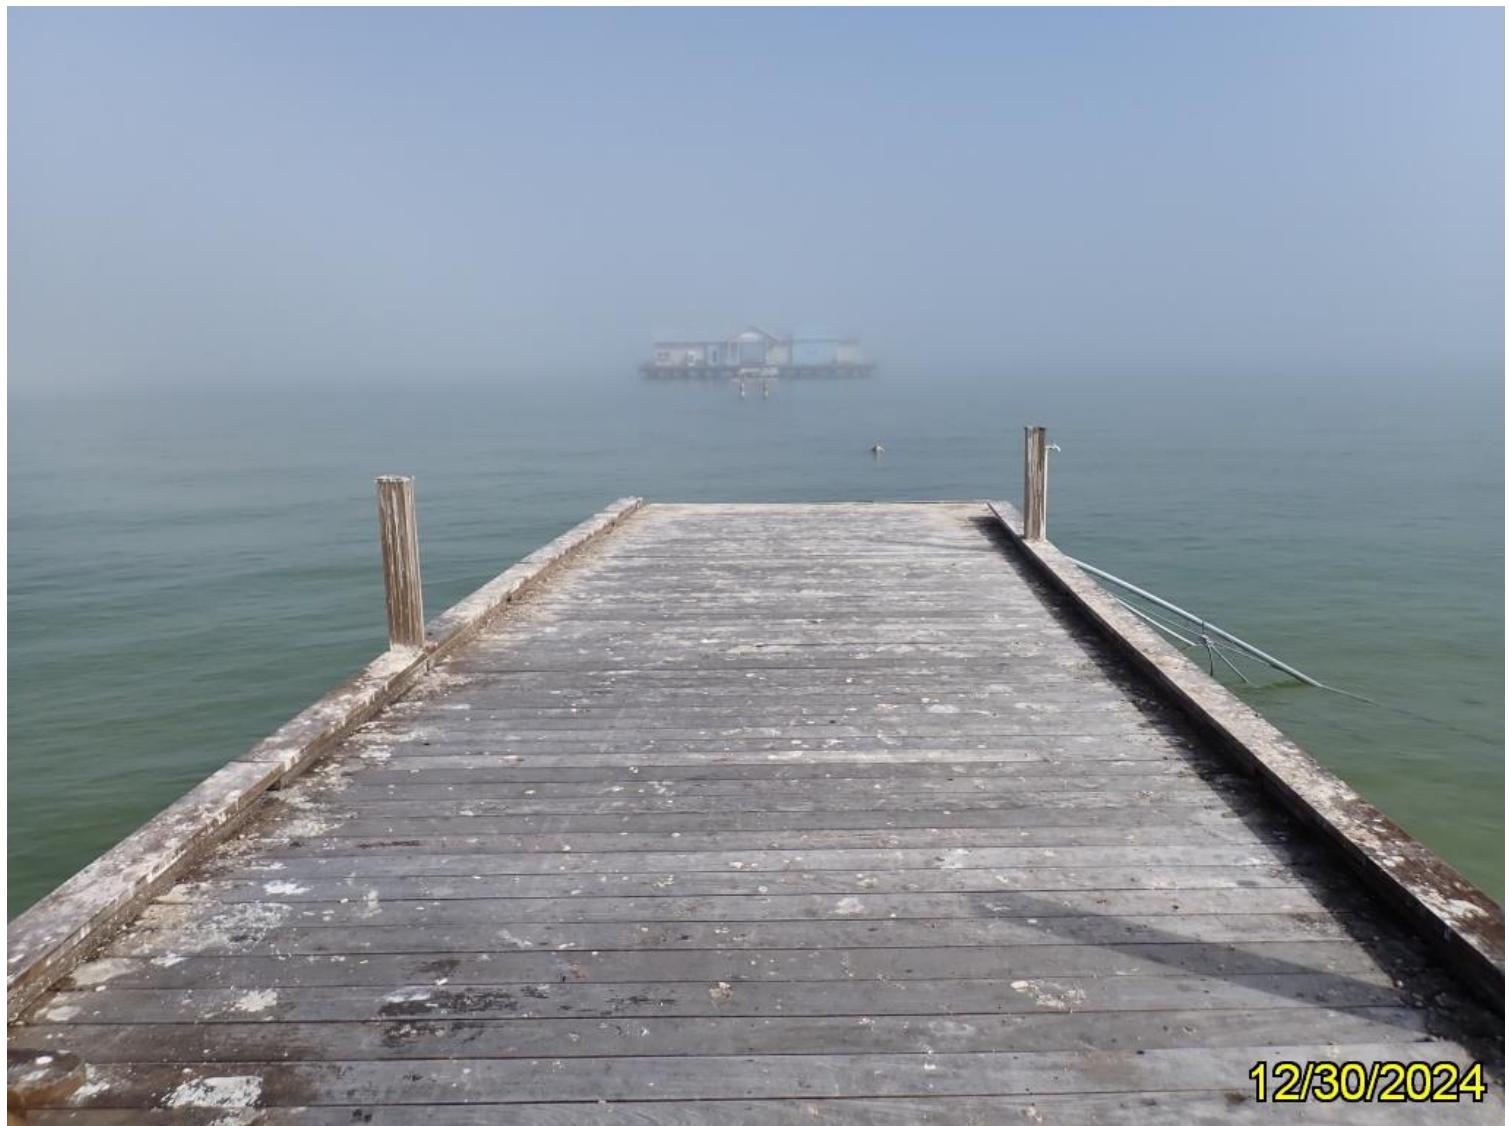
**Photo 1: Elements 60 Other Deck & 227 Re Conc Pile & 235 Timber Pier Cap & 111 Timber Open Girder**

Note: The deck top, from Bent 21 to the 3rd bent out from the bait house are missing or failed besides one bent remaining (approximately 1/2 of the way to the bait house). The missing or failed portions of the deck are not quantified – NEW. Refer to Photo 1.

Note: The piles from Bent 21 to the 3rd bent out from the bait house are missing or failed besides one bent remaining (approximately 1/2 of the way to the bait house). The missing or failed piles are not quantified. – NEW. Refer to Photo 1.

Note: The bent caps from Bent 21 to the 3rd bent out from the bait house are missing or failed besides one bent remaining (approximately 1/2 of the way to the bait house). The missing or failed bent caps are not quantified. – NEW. Refer to Photo 1.

Note: The stringers from Bent 21 to the 3rd bent out from the bait house are missing or failed besides one bent remaining (approximately 1/2 of the way to the bait house). The missing or failed stringers are not quantified. – NEW. Refer to Photo 1.

Based on our observations, it is assumed that the pier piles failed due to a combination of wind, waves, and storm surge during the hurricane. The intense wave action and storm surge may have scoured the seabed, reduced the embedment depth of the piles, and compromised their stability. Additionally, the piles may have experienced excessive bending and shear stresses from wind-driven waves, potentially leading to structural buckling or displacement. The combination of these factors likely caused the piles to lose their load-bearing capacity, resulting in the progressive collapse of the remaining portions of the pier.

Missing or failed deck top, stringers, bent caps and piles from Bent 21 to the 3rd bent out from the bait house.

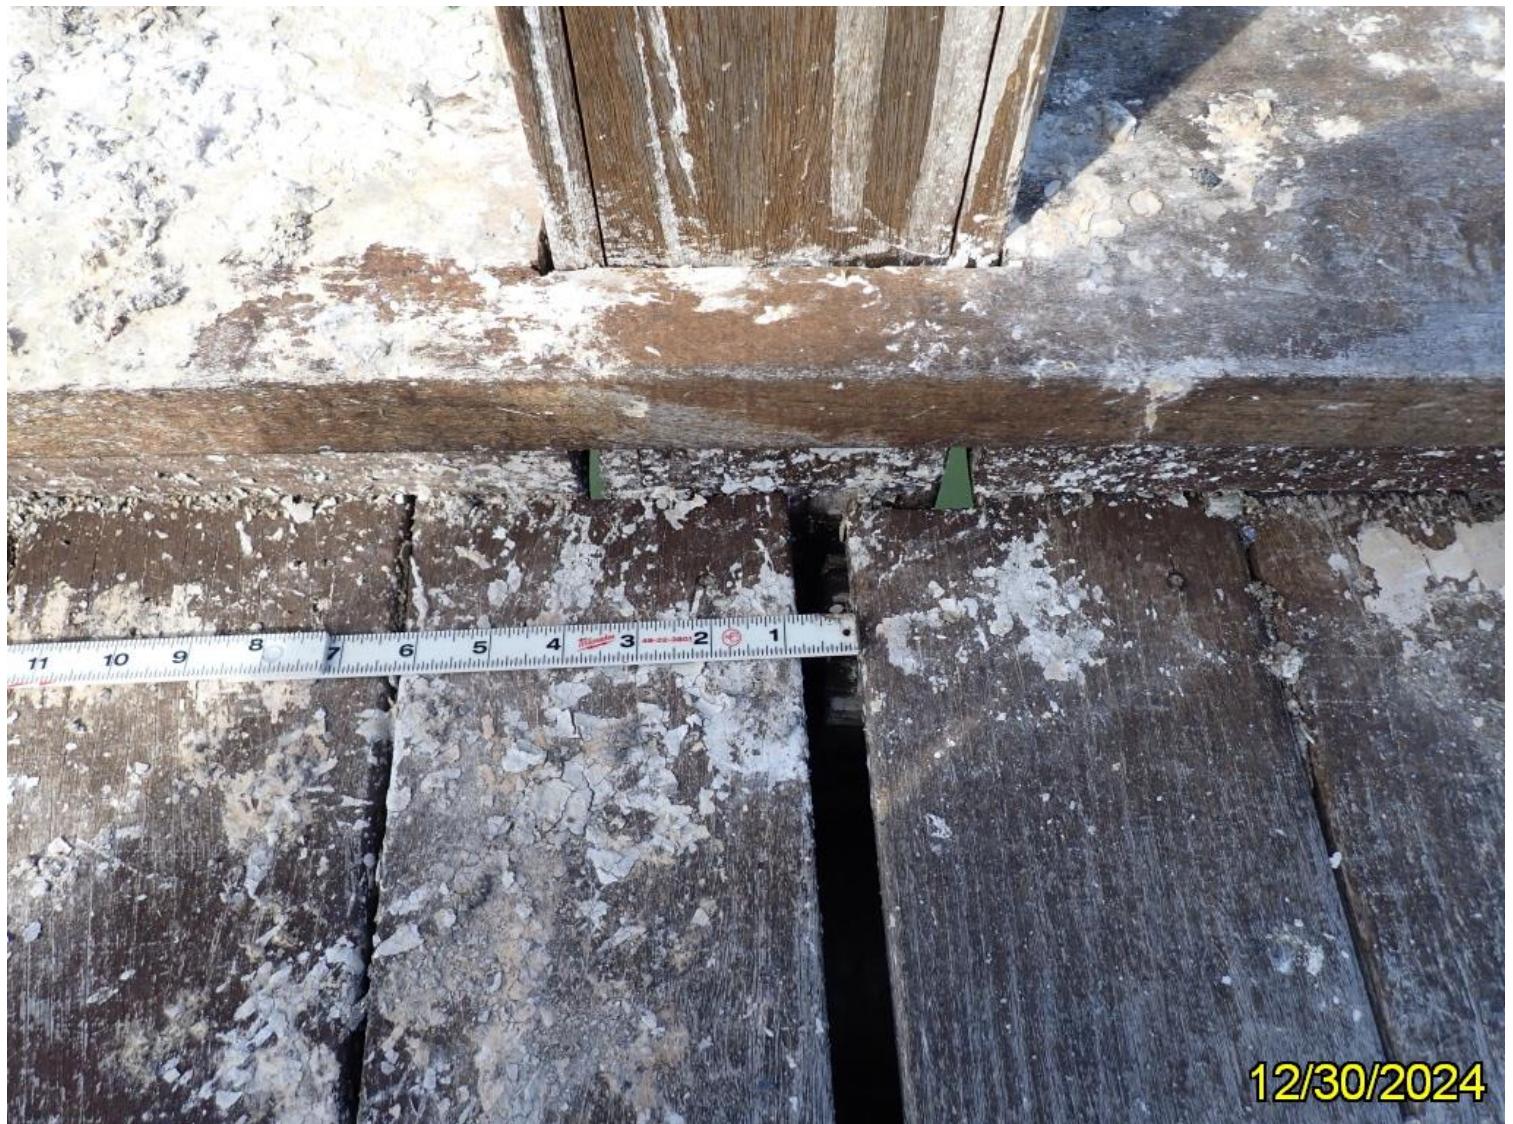
**Photo 2: Element 60 Other Deck**

CS1 = The deck top over Bent 19 has shifted towards the east up to 7/8in. – NEW. Refer to Photo 2. Refer to Element 227 Re Conc Pile for related deficiencies.

Span 19 over Bent 19 shifted towards the east.

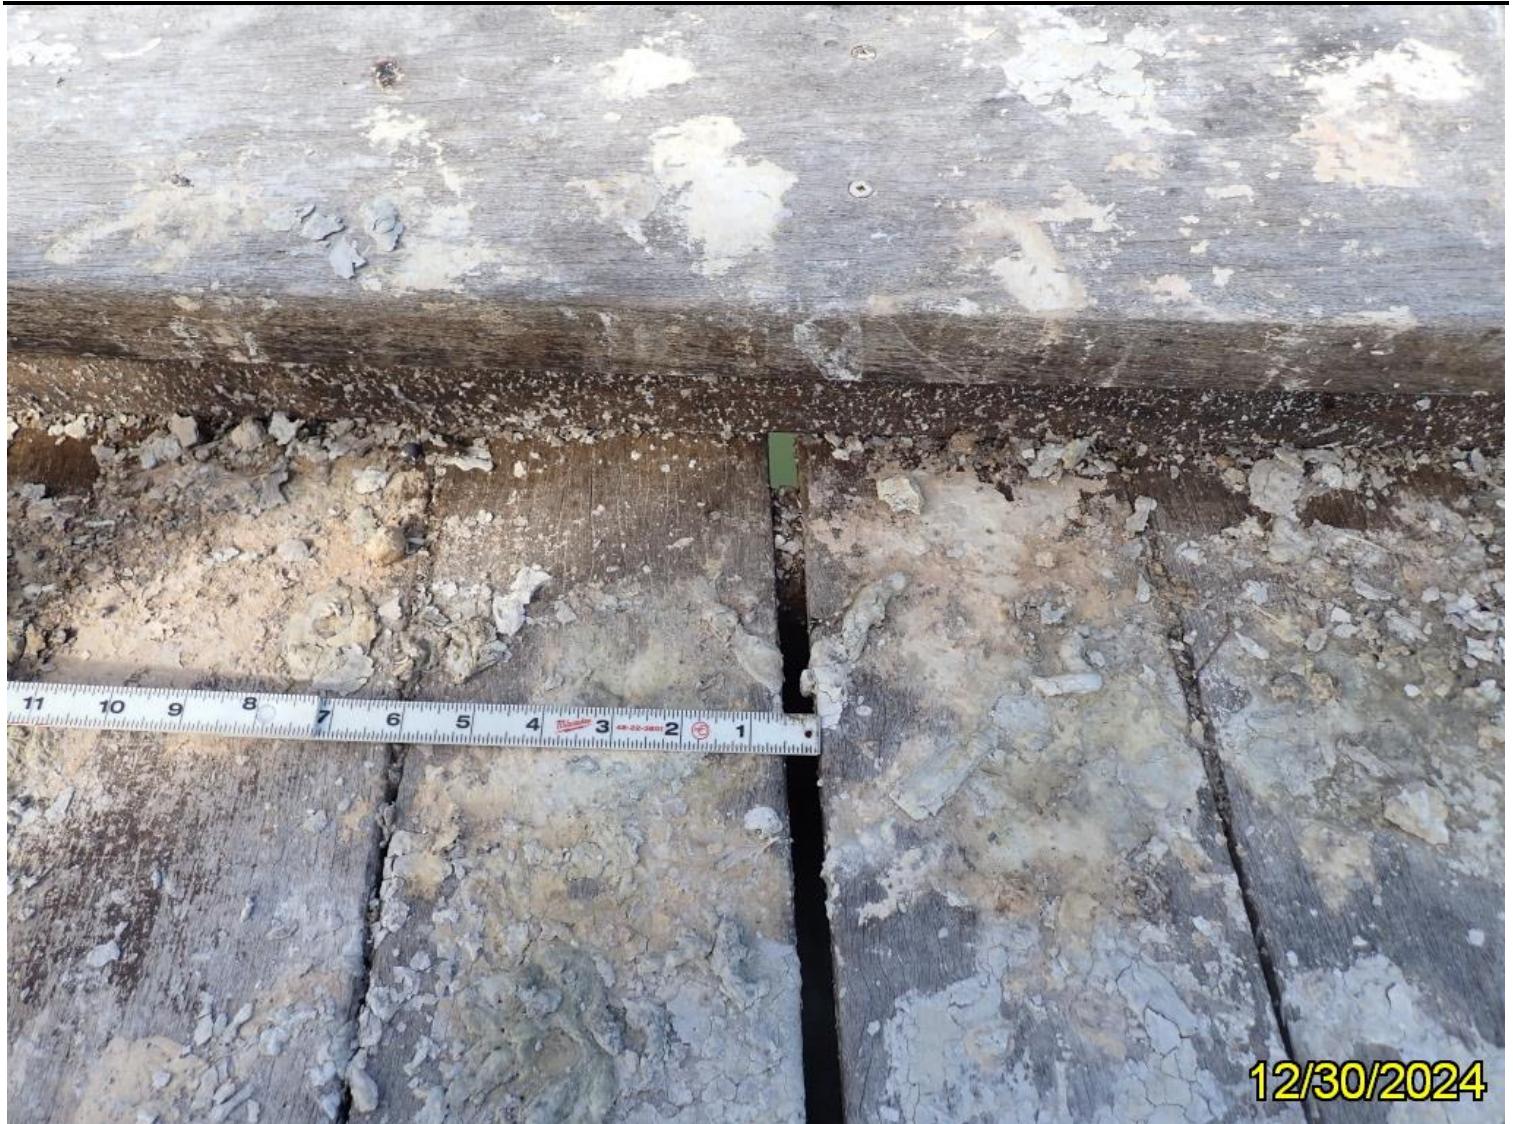
**Photo 3: Element 60 Other Deck**

CS1 = The deck top over Bent 20 has shifted towards the east up to 1/2in. – NEW. Refer to Photo 3. Refer to Element 227 Re Conc Pile for related deficiencies.

Span 20 over Bent 20 shifted towards the east

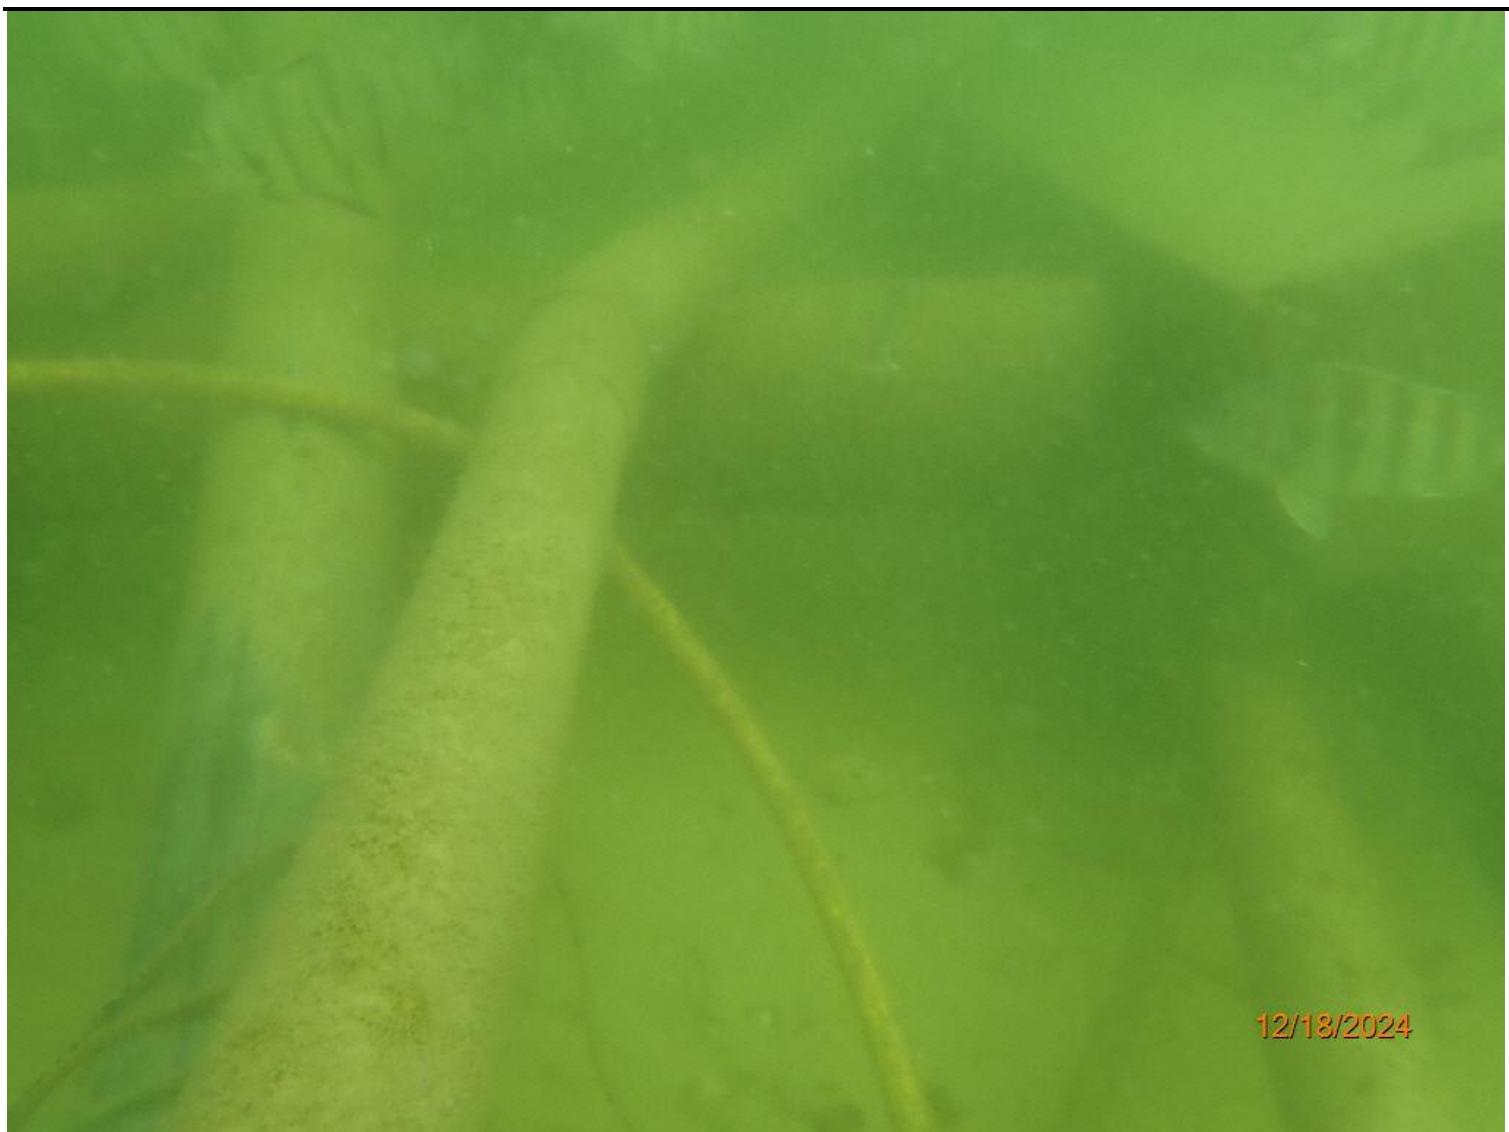
**Photo 4: Element 8290 Channel**

CS3 9140 = The channel from Bent 21 to the 3rd bent out from the bait house has numerous piles and caps laying on the channel floor - NEW. Refer to Photos 4. (1EA)

Typical piles and bent caps laying on the channel floor

Remove debris throughout the channel floor.

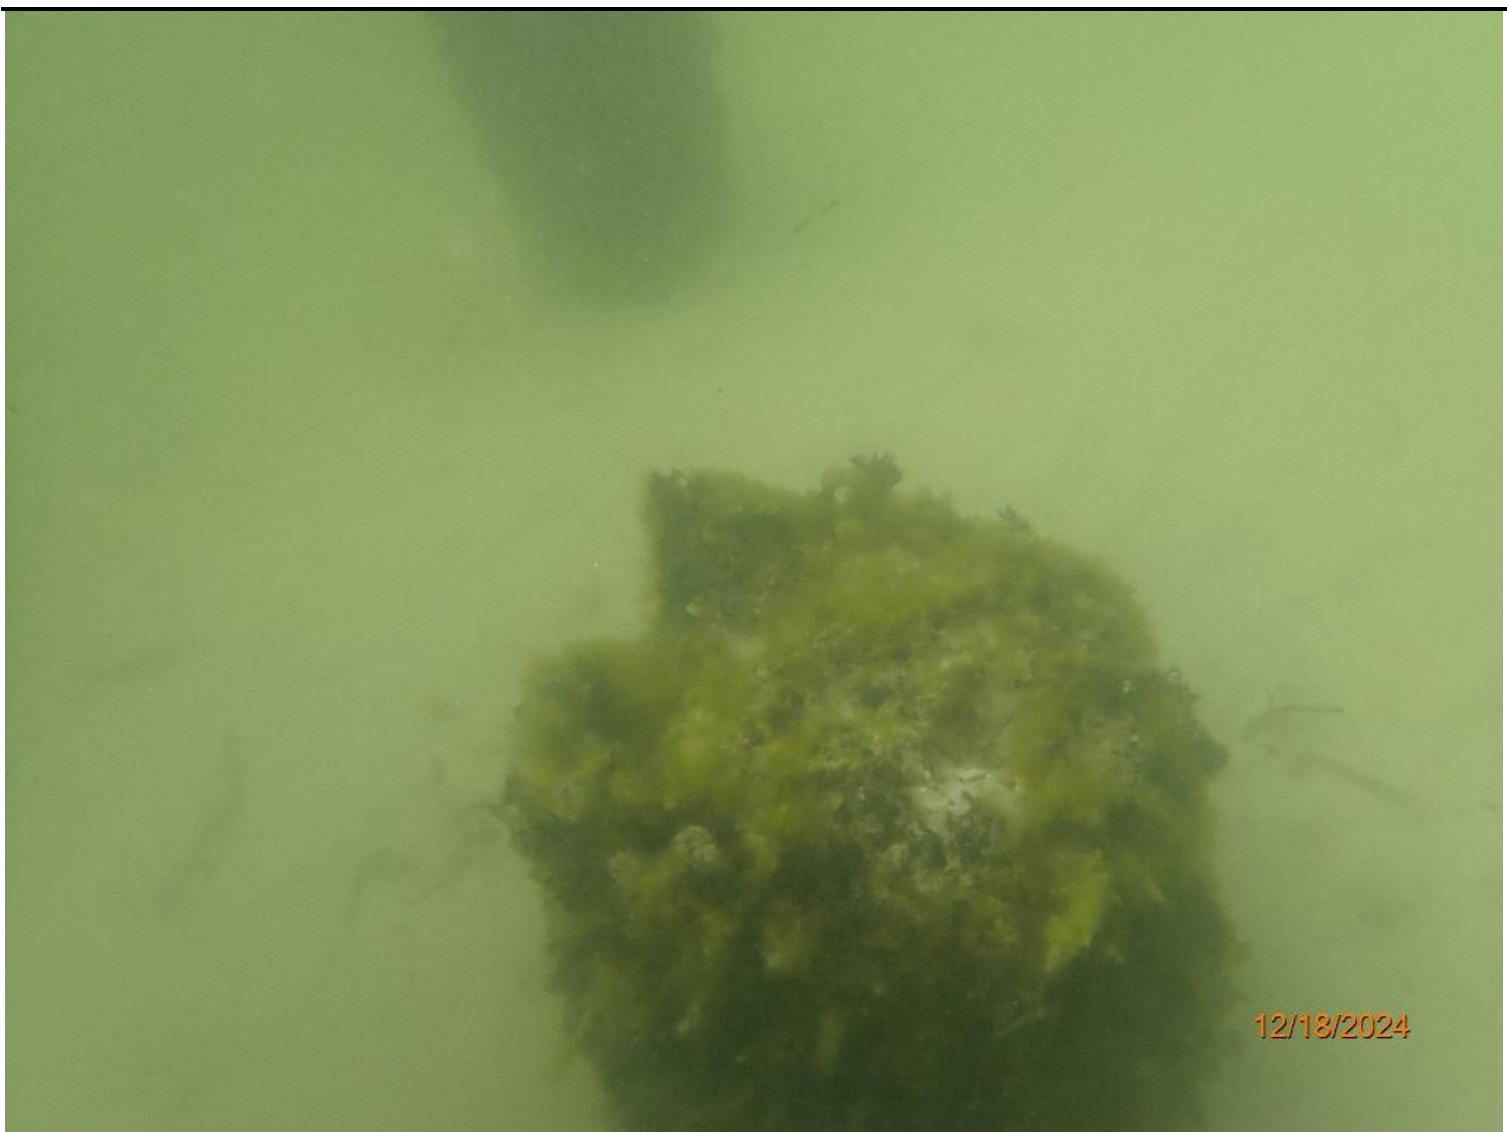
**Photo 5: Element 8290 Channel**

There are old timber pile stubs extending up to 3ft. 3in. above the groundline throughout the area - NEW. Refer to Photo 5.

Typical timber pile stubs extending above the groundline

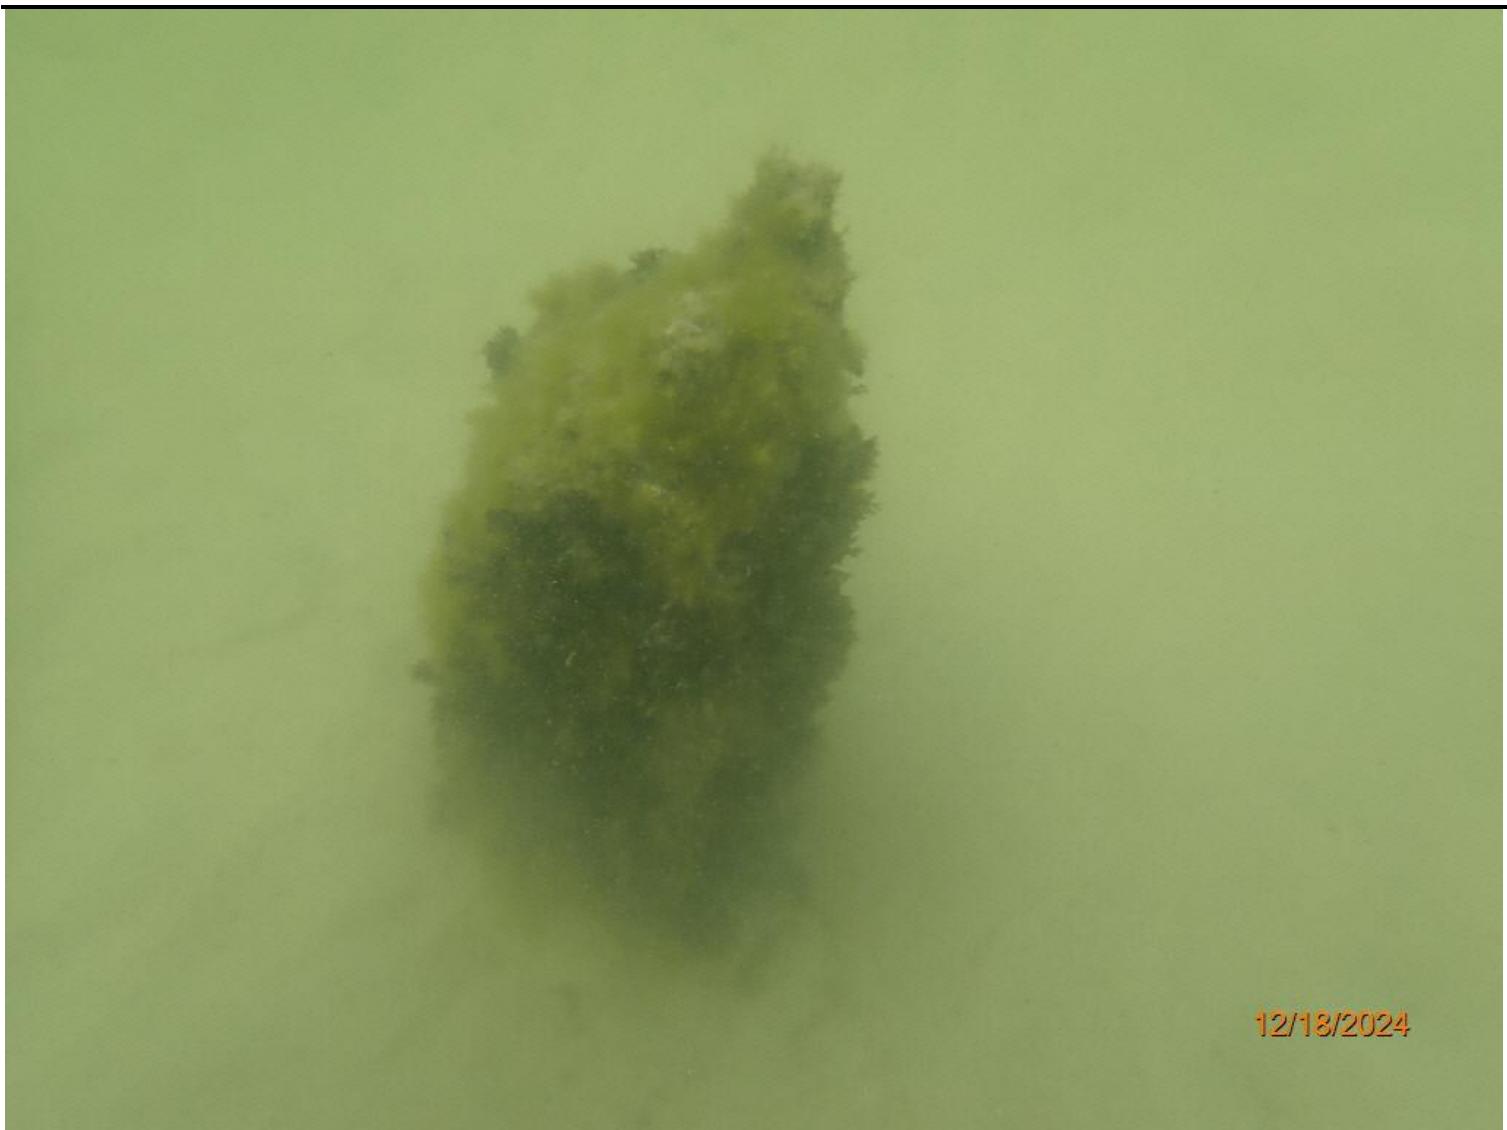
**Photo 6: Element 8290 Channel**

There are 7in. concrete stubs extending up to 14in. above the groundline and cut-offs laying on the ground that extend approximately 120ft. to the east, beyond Bent 21 - NEW. Refer to Photo 6.

Typical concrete stubs extending above the groundline.

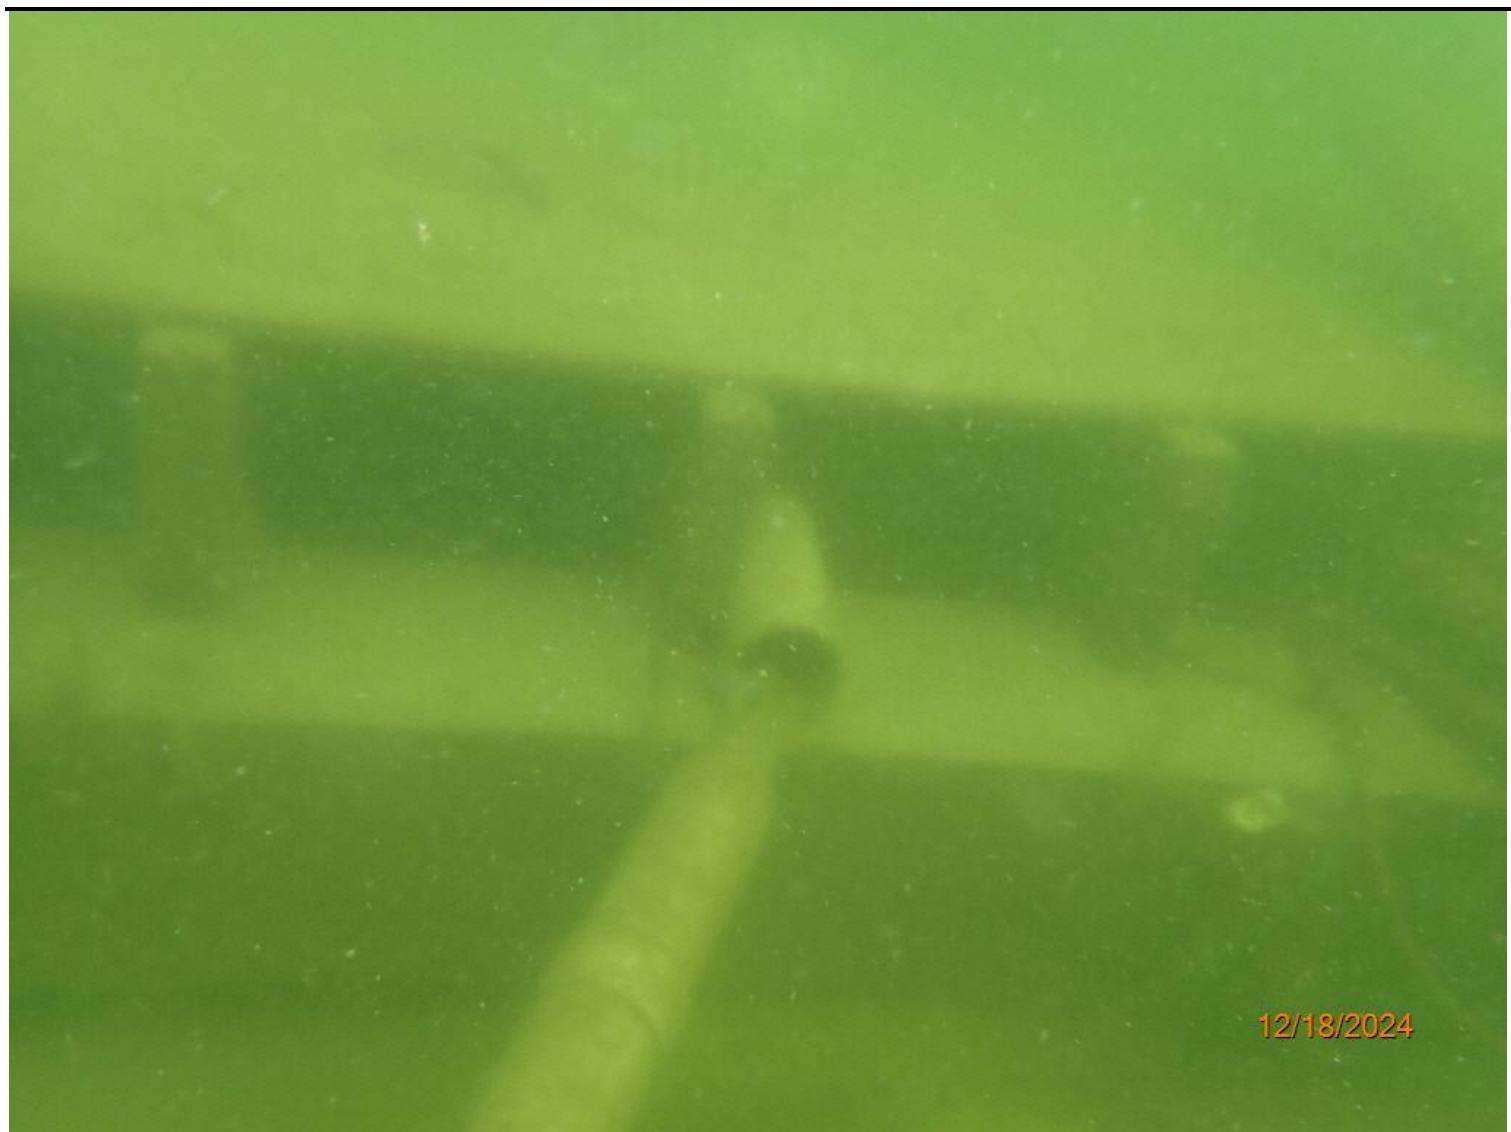
**Photo 7: Element 8290 Channel**

There is a portion of the deck with the caps still attached approximately 100ft. from the bait house 8ft. in length and a second section 50ft. from the bait house 10ft. in length - NEW. Refer to Photo 7.

Typical deck with the caps attached laying on the channel floor

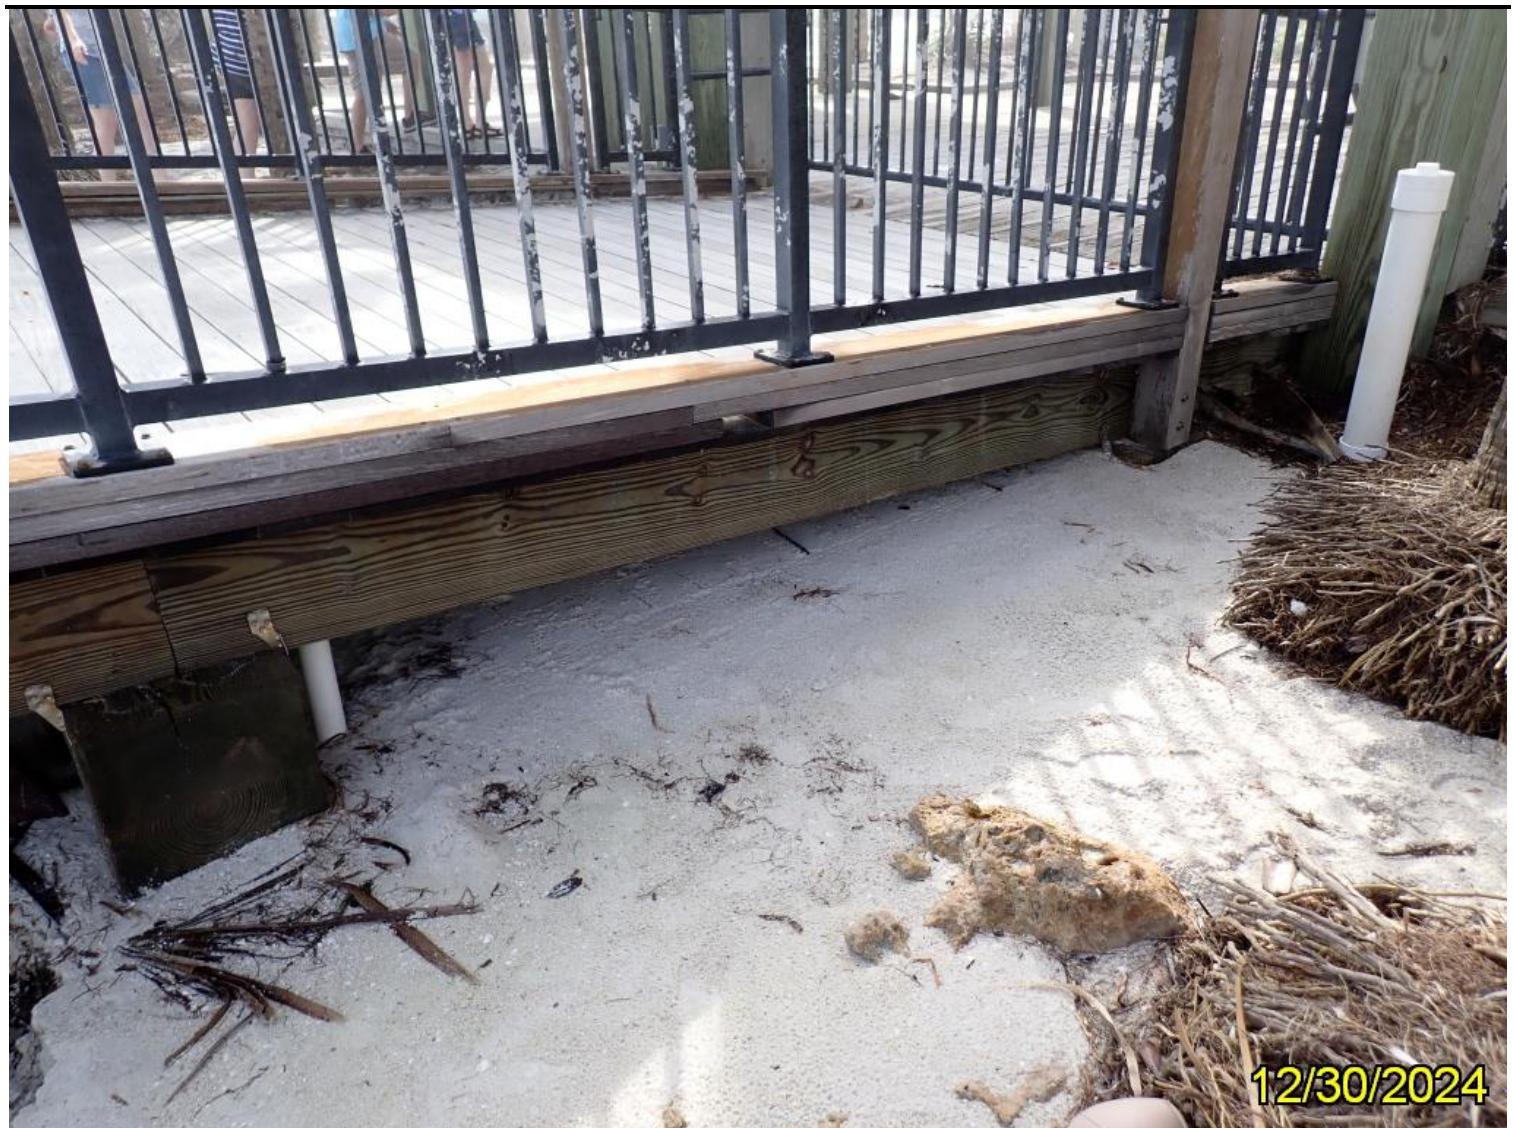
**Photo 8: Element 216 Timber Abutment**

Abutment 1 was buried at time of inspection. This appears to be intentional. Refer to Photo 8.

Abutment 1 buried

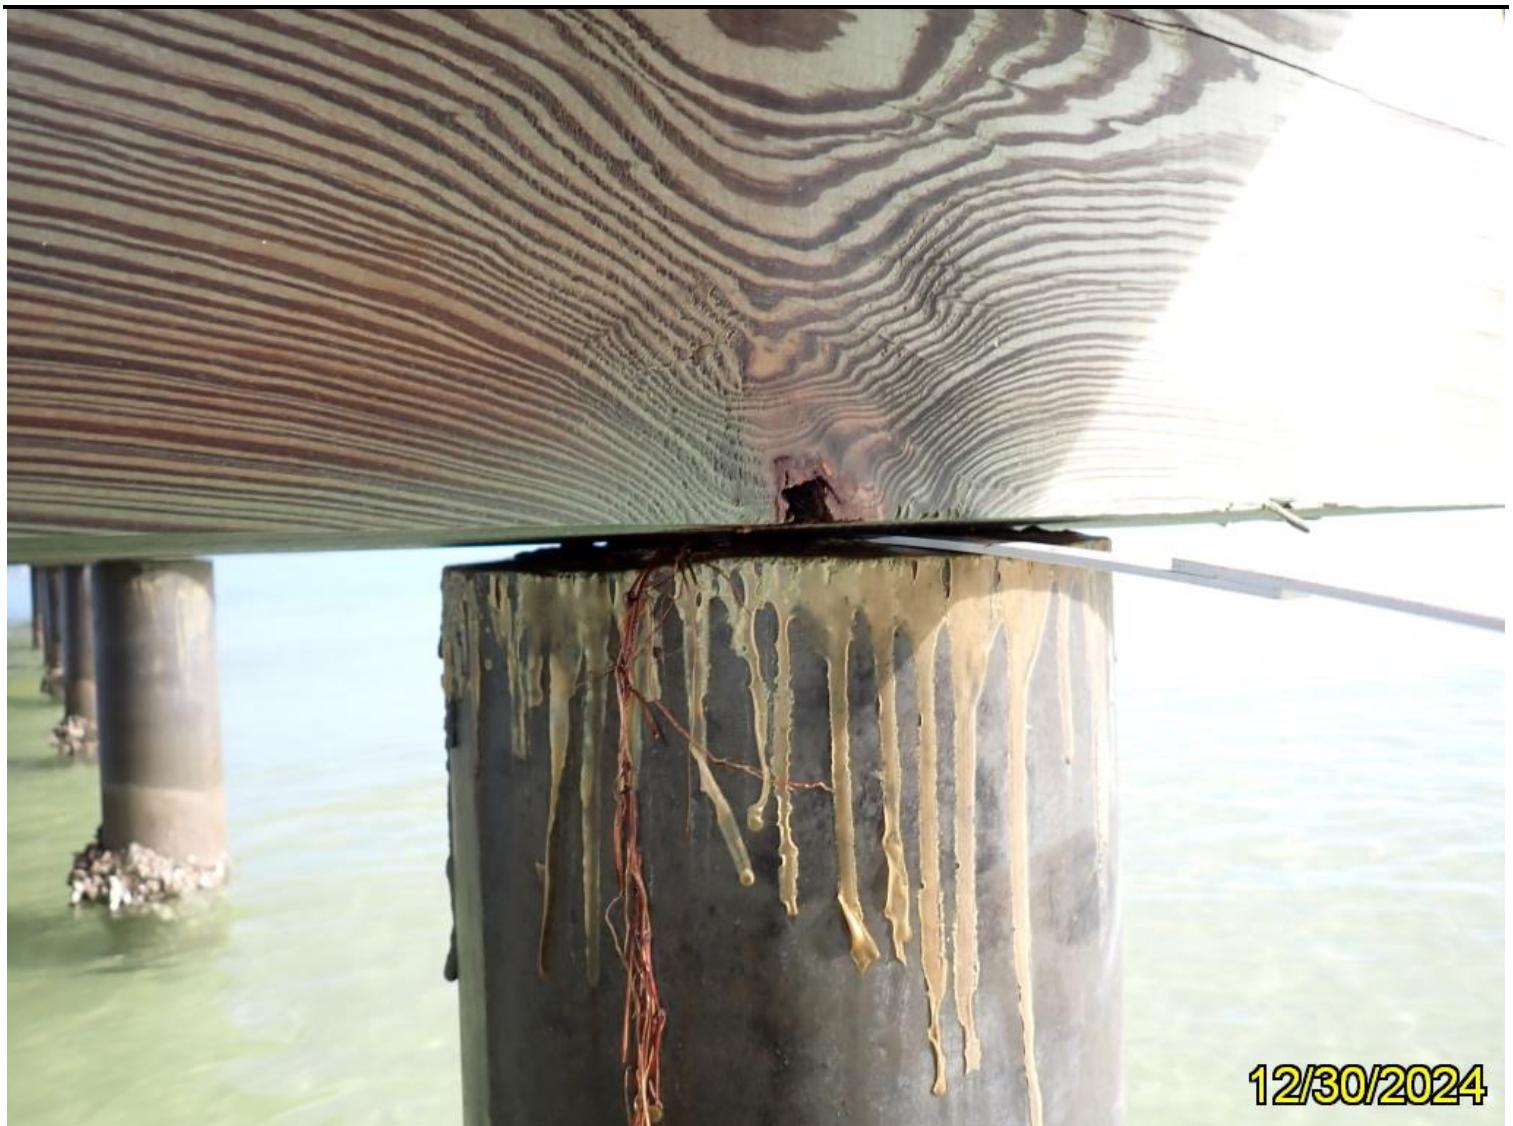
**Photo 9: Element 227 Re Conc Pile**

CS1 = The piles have areas of lack of bearing up to 40% throughout, this condition appears to be construction related due to the top of the piles not being flush with the caps – NEW. Refer to Photo 9.

Typical pile lack of bearing

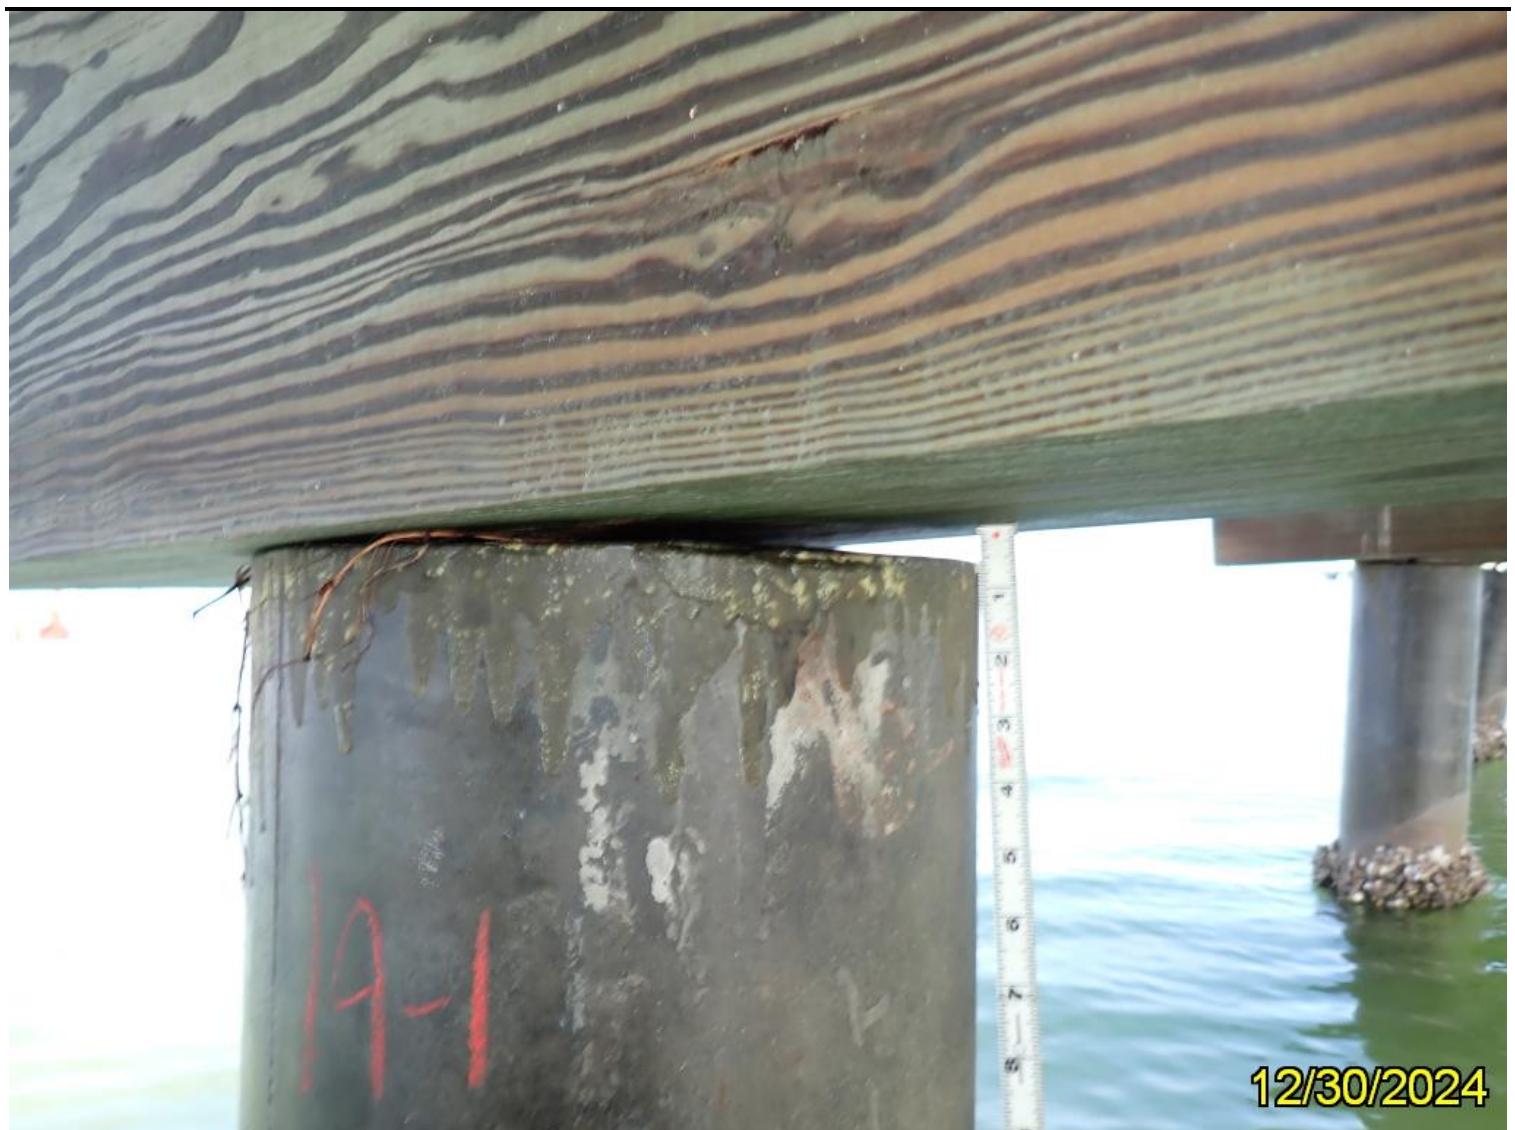
**Photo 10: Element 227 Re Conc Pile**

CS3 4000 = Pile 19-1 has settled and is leaning towards the east causing gaps along the east quadrant up to 1/2in. high resulting in 60% loss of bearing, due to the piles leaning the deck in Span 19 has shifted towards the east up to 7/8in. – NEW. Refer to Photo 10. (1EA)

Pile 19-1 leaning towards the east causing a gap along the east quadrant

Install new piles to support Bents 19, 20 and 21.

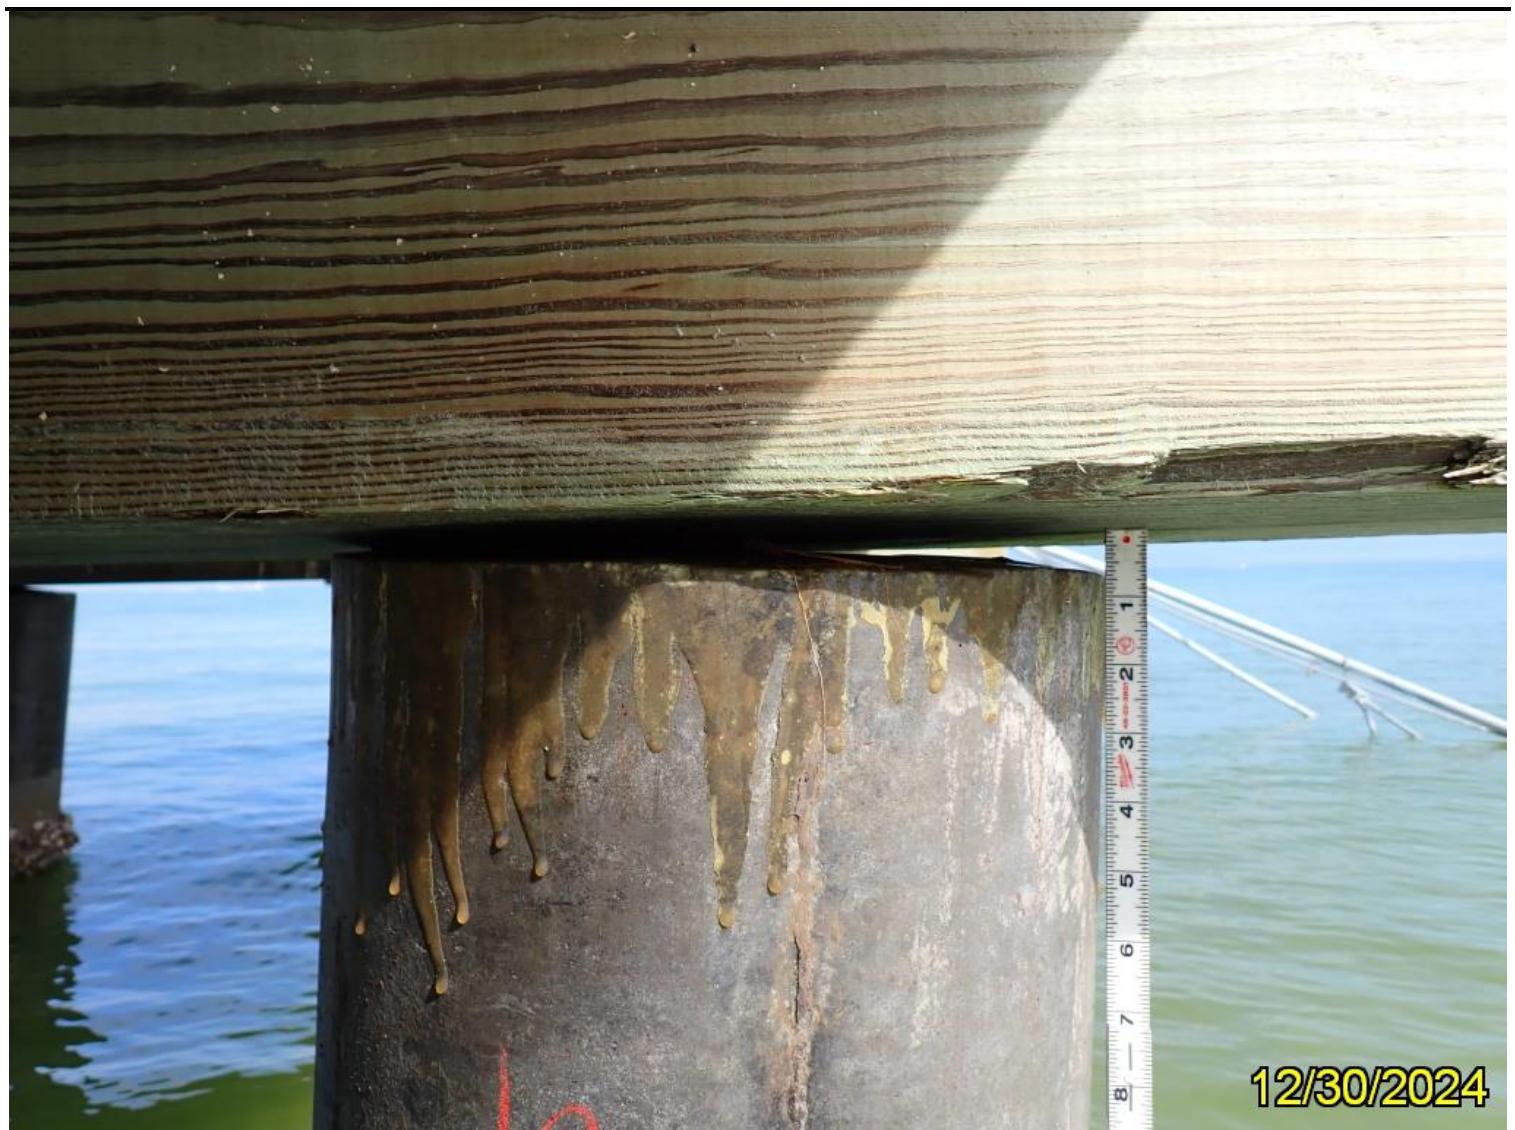
**Photo 11: Element 227 Re Conc Pile**

CS3 4000 = Pile 19-2 has settled and is leaning towards the east causing gaps along the east quadrant up to 3/4in. high resulting in 70% loss of bearing, due to the piles leaning the deck in Span 19 has shifted towards the east up to 7/8in. – NEW. Refer to Photo 11. (1EA)

Pile 19-2 leaning towards the east causing a gap along the east quadrant

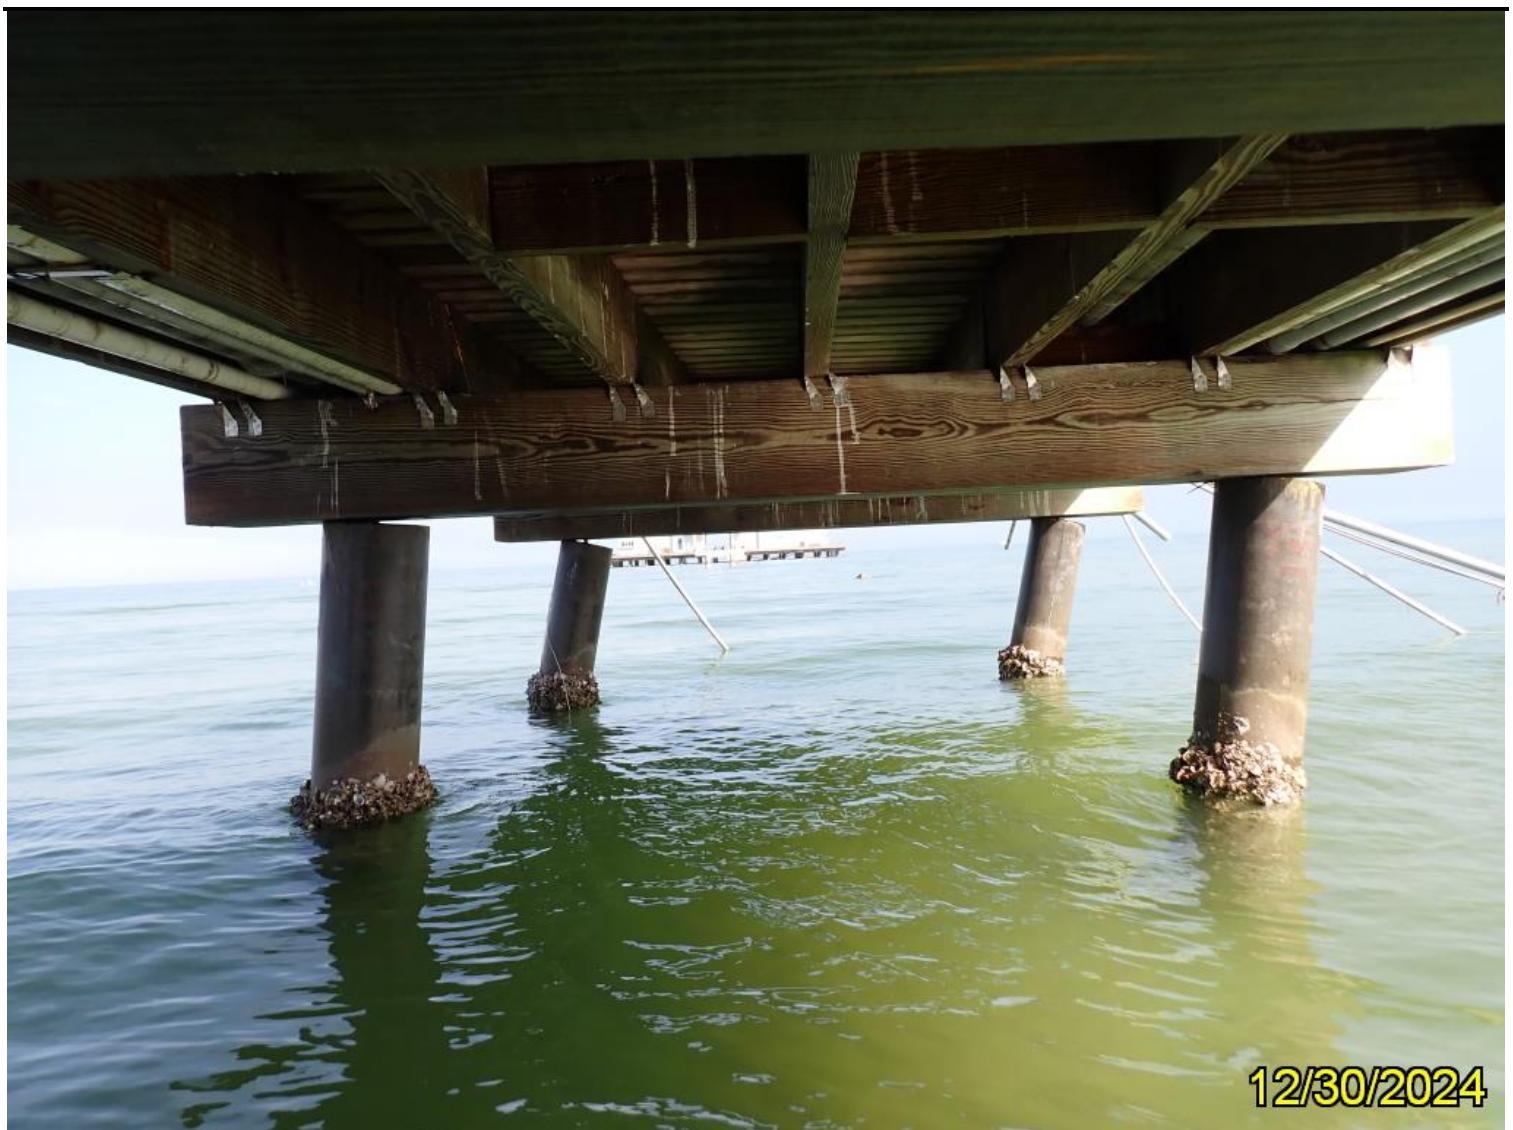
**Photo 12: Element 227 Re Conc Pile**

CS4 4000 = Pile 20-1 has settled and is leaning towards the east causing gaps along the east quadrant up to 1in. high resulting in 80% loss of bearing, due to the piles leaning the deck in Span 19 has shifted towards the east up to 7/8in. and in Span 20 up to 1/2in. – NEW. Refer to Photos 12 and 13. (1EA)

Overview of Bent 20 piles leaning towards the east
