**ANNA MARIA ISLAND  
Inspection Report  
Inspection**

**Structure ID: Anna Maria Island City Pier  
DISTRICT: D1 - Bartow**

**INSPECTION DATE: 12/30/2024**

TYPE OF INSPECTION: Regular NBI

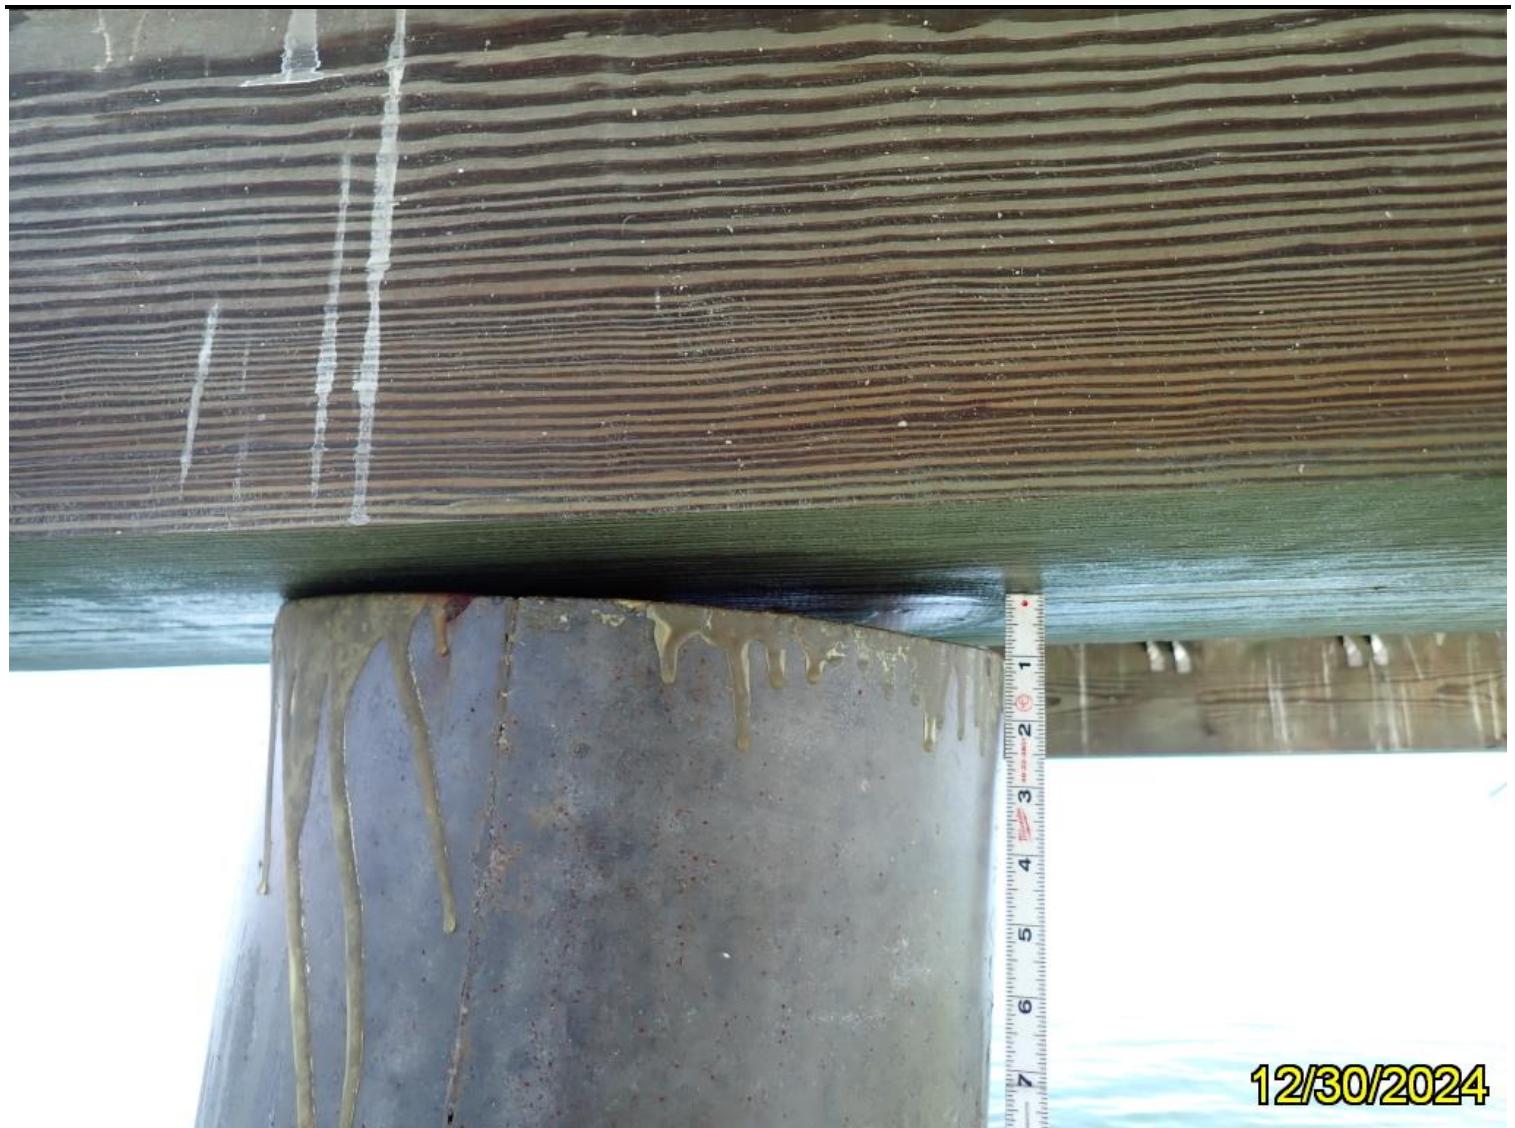
**Photo 13: Element 227 Re Conc Pile**

CS4 4000 = Pile 20-1 has settled and is leaning towards the east causing gaps along the east quadrant up to 1in. high resulting in 80% loss of bearing, due to the piles leaning the deck in Span 19 has shifted towards the east up to 7/8in. and in Span 20 up to 1/2in. – NEW. Refer to Photos 12 and 13. (1EA)

Pile 20-1 leaning towards the east causing a gap along the east quadrant

Install new piles to support Bents 19, 20 and 21.

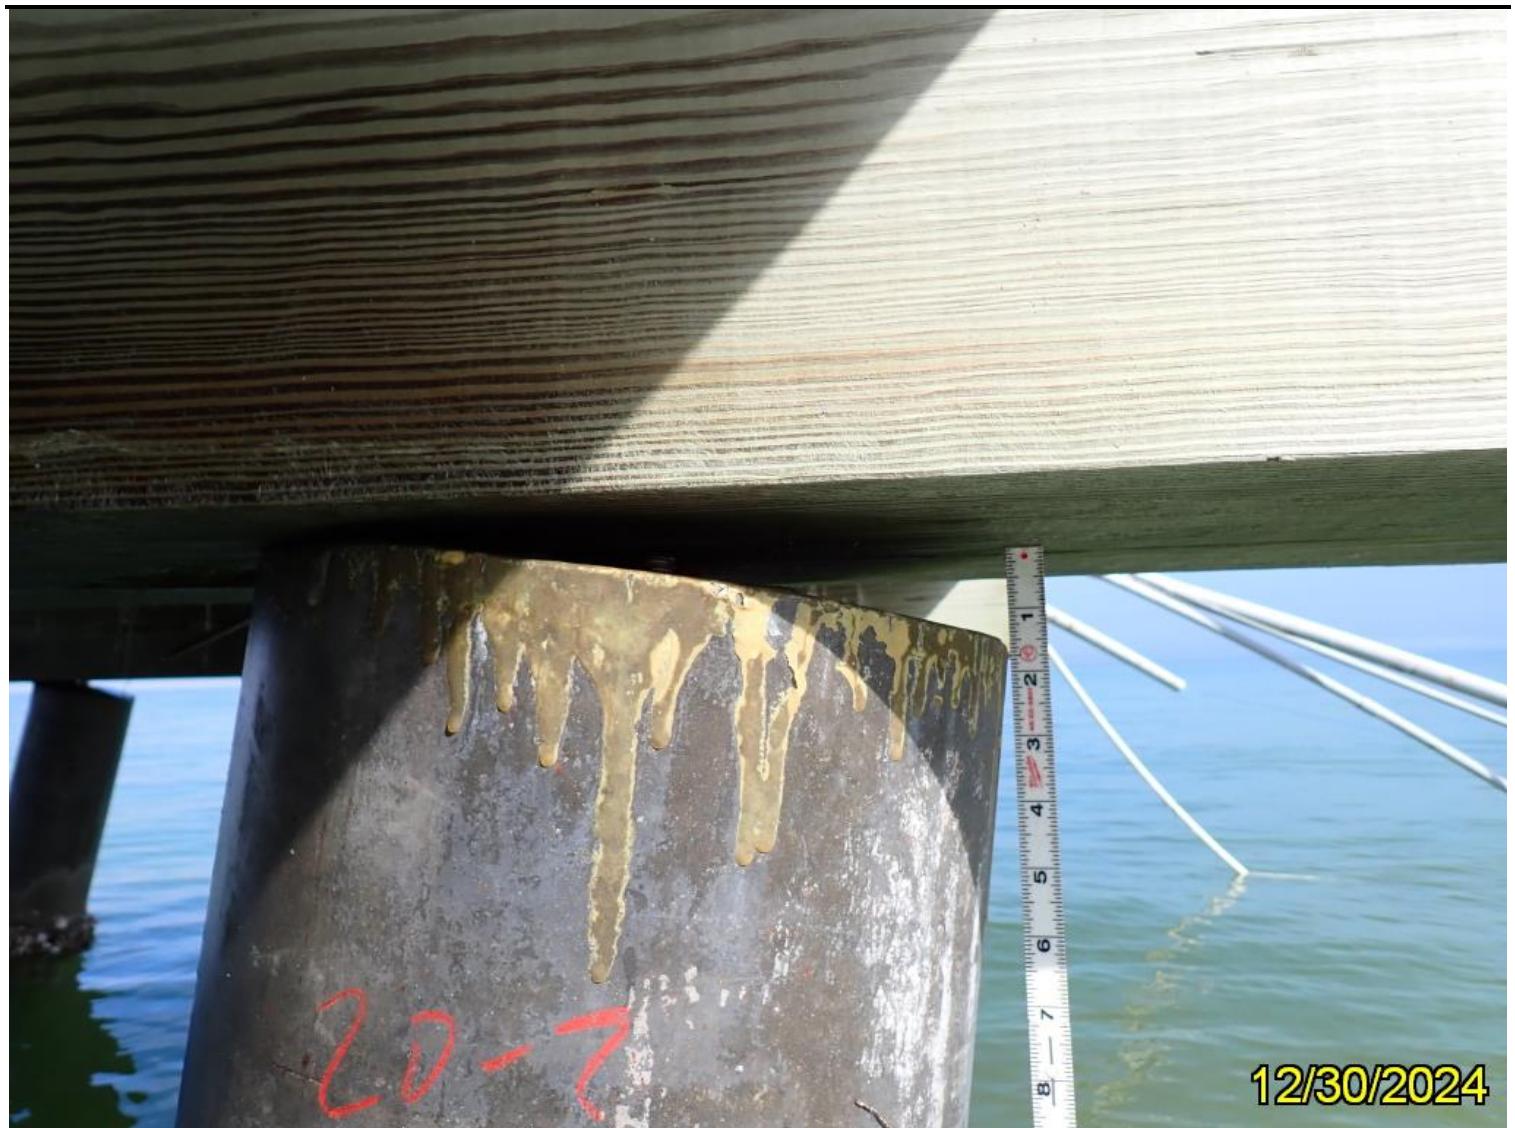
**Photo 14: Element 227 Re Conc Pile**

CS4 4000 = Pile 20-2 has settled and is leaning towards the east causing gaps along the east quadrant up to 1-5/8in. high resulting in 80% loss of bearing, due to the piles leaning the deck in Span 19 has shifted towards the east up to 7/8in. and in Span 20 up to 1/2in. – NEW. Refer to Photo 14. (1EA)

Pile 20-2 leaning towards the east causing a gap along the east quadrant

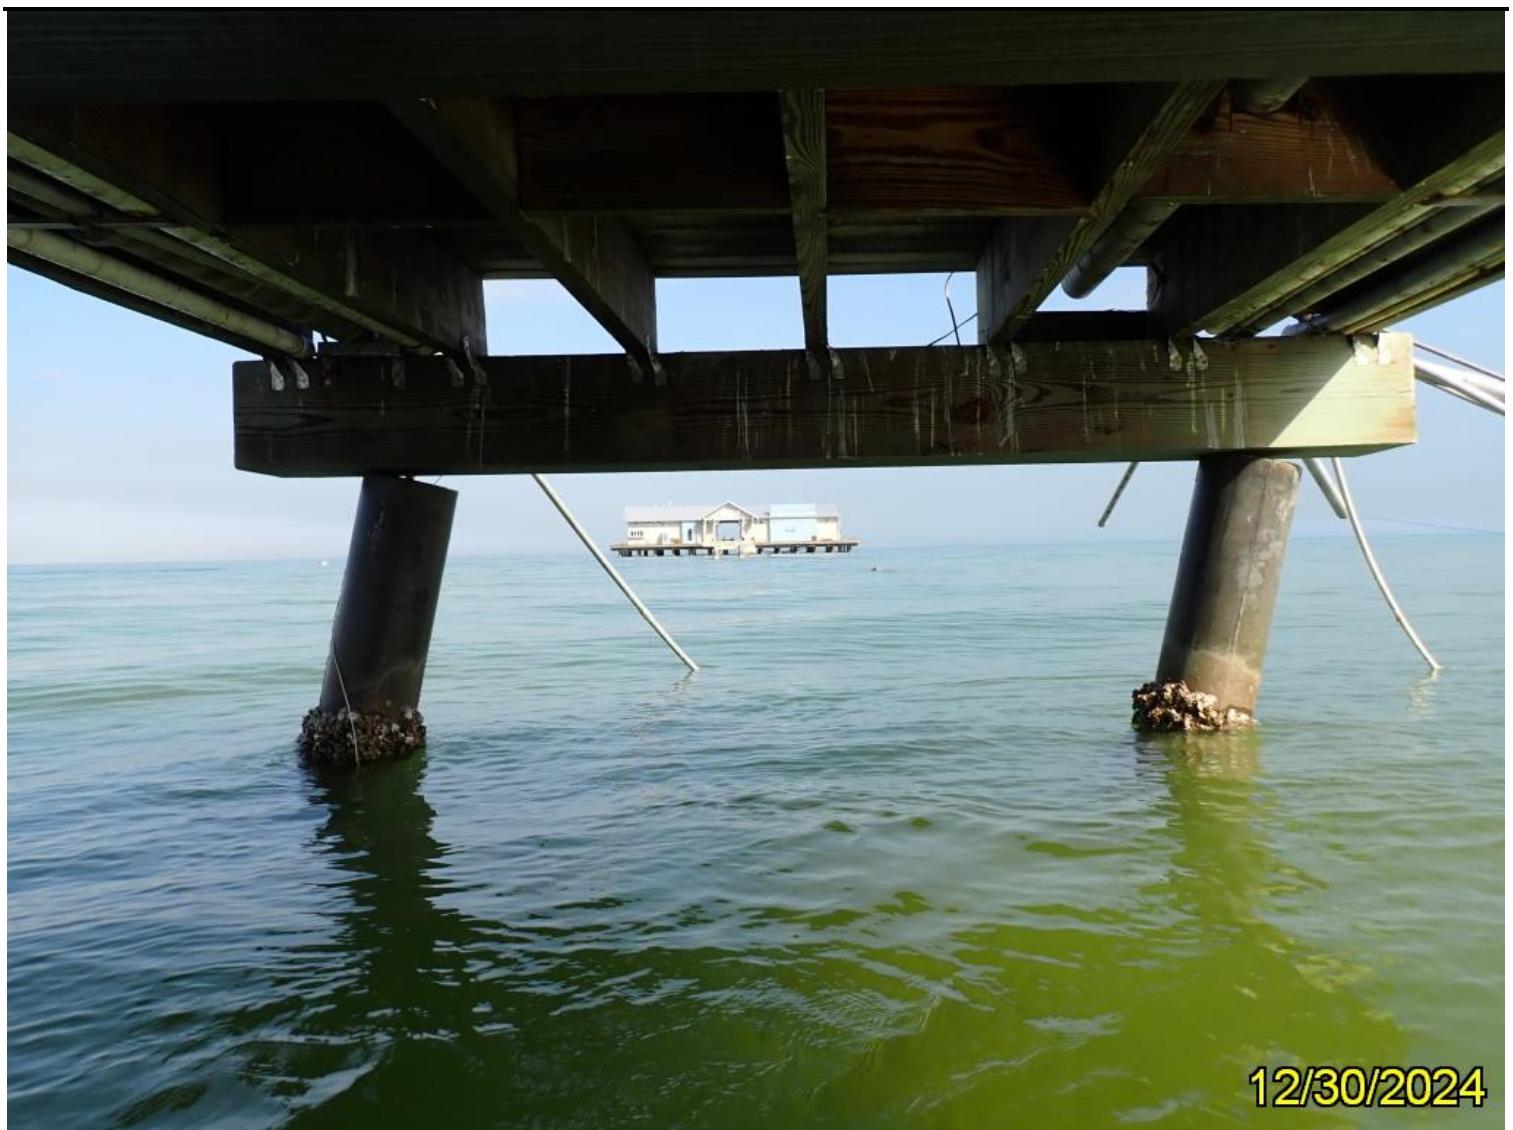
**Photo 15: Element 227 Re Conc Pile**

CS4 4000 = Pile 21-1 has settled and is leaning towards the east causing gaps along the east quadrant up to 2-1/4in. high resulting in 95% loss of bearing, due to the piles leaning the deck in Span 20 has shifted towards the east up to 1/2in. – NEW. Refer to Photos 15 and 16. (1EA)

Overview of Bent 21 piles leaning towards the east

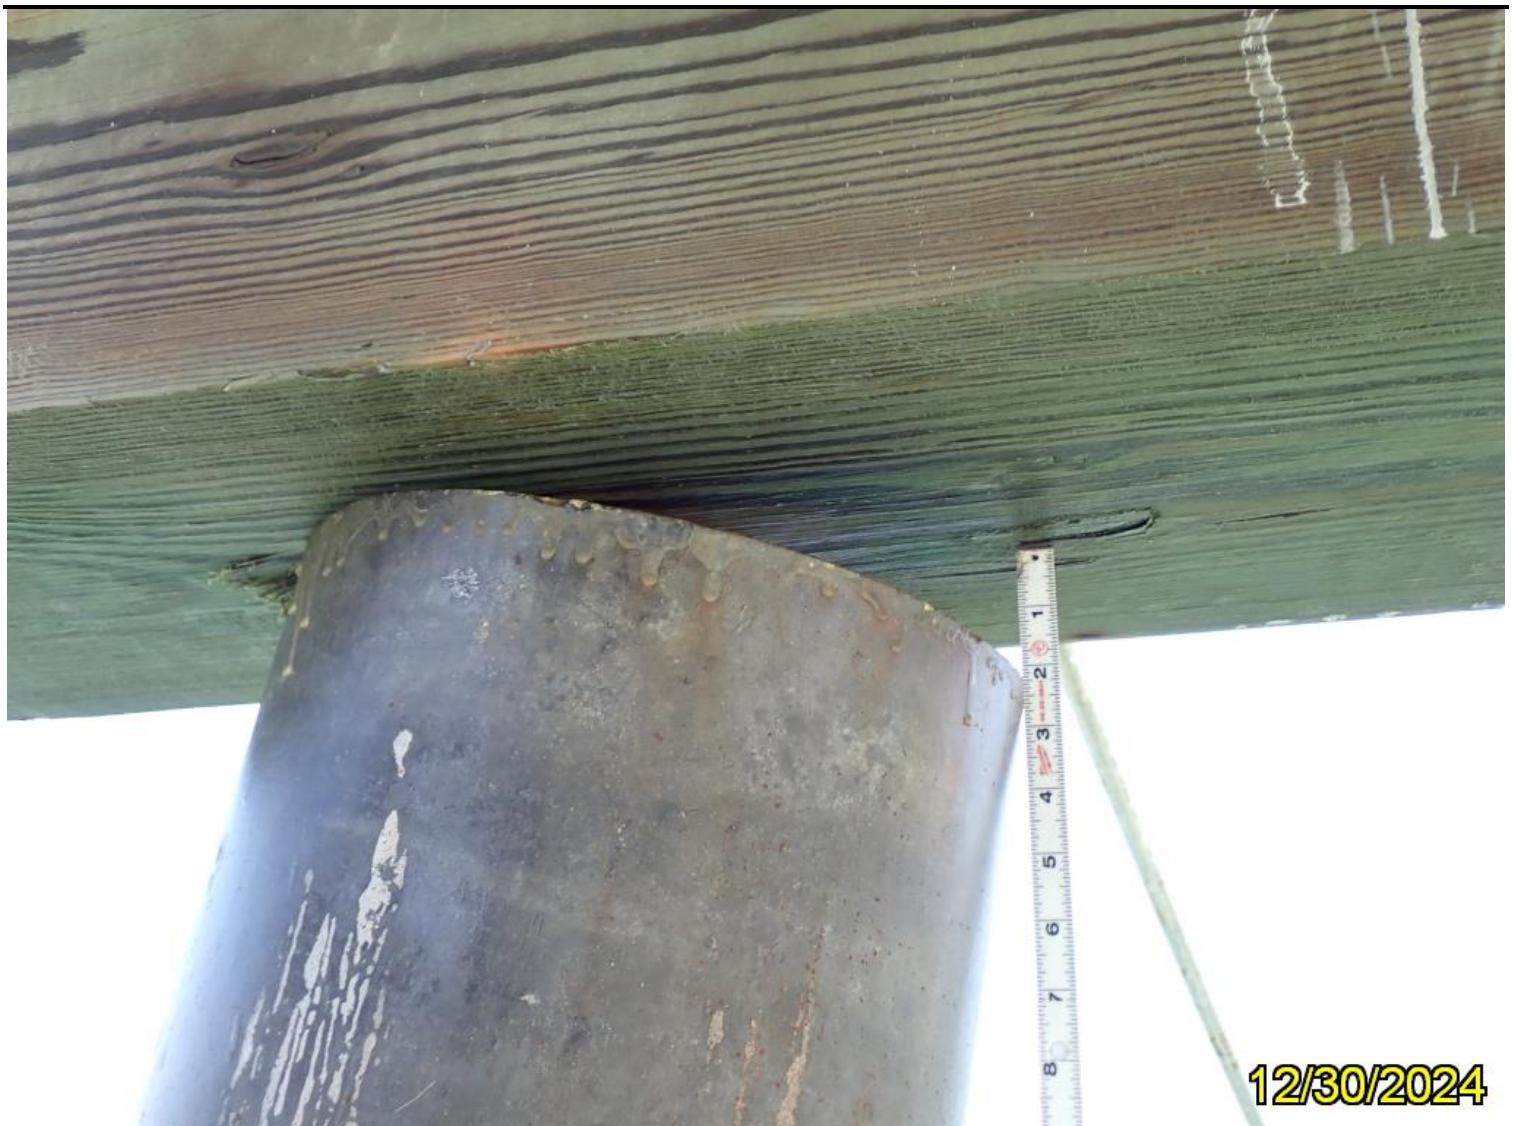
**Photo 16: Element 227 Re Conc Pile**

Pile 21-1 leaning towards the east causing a gap along the east quadrant

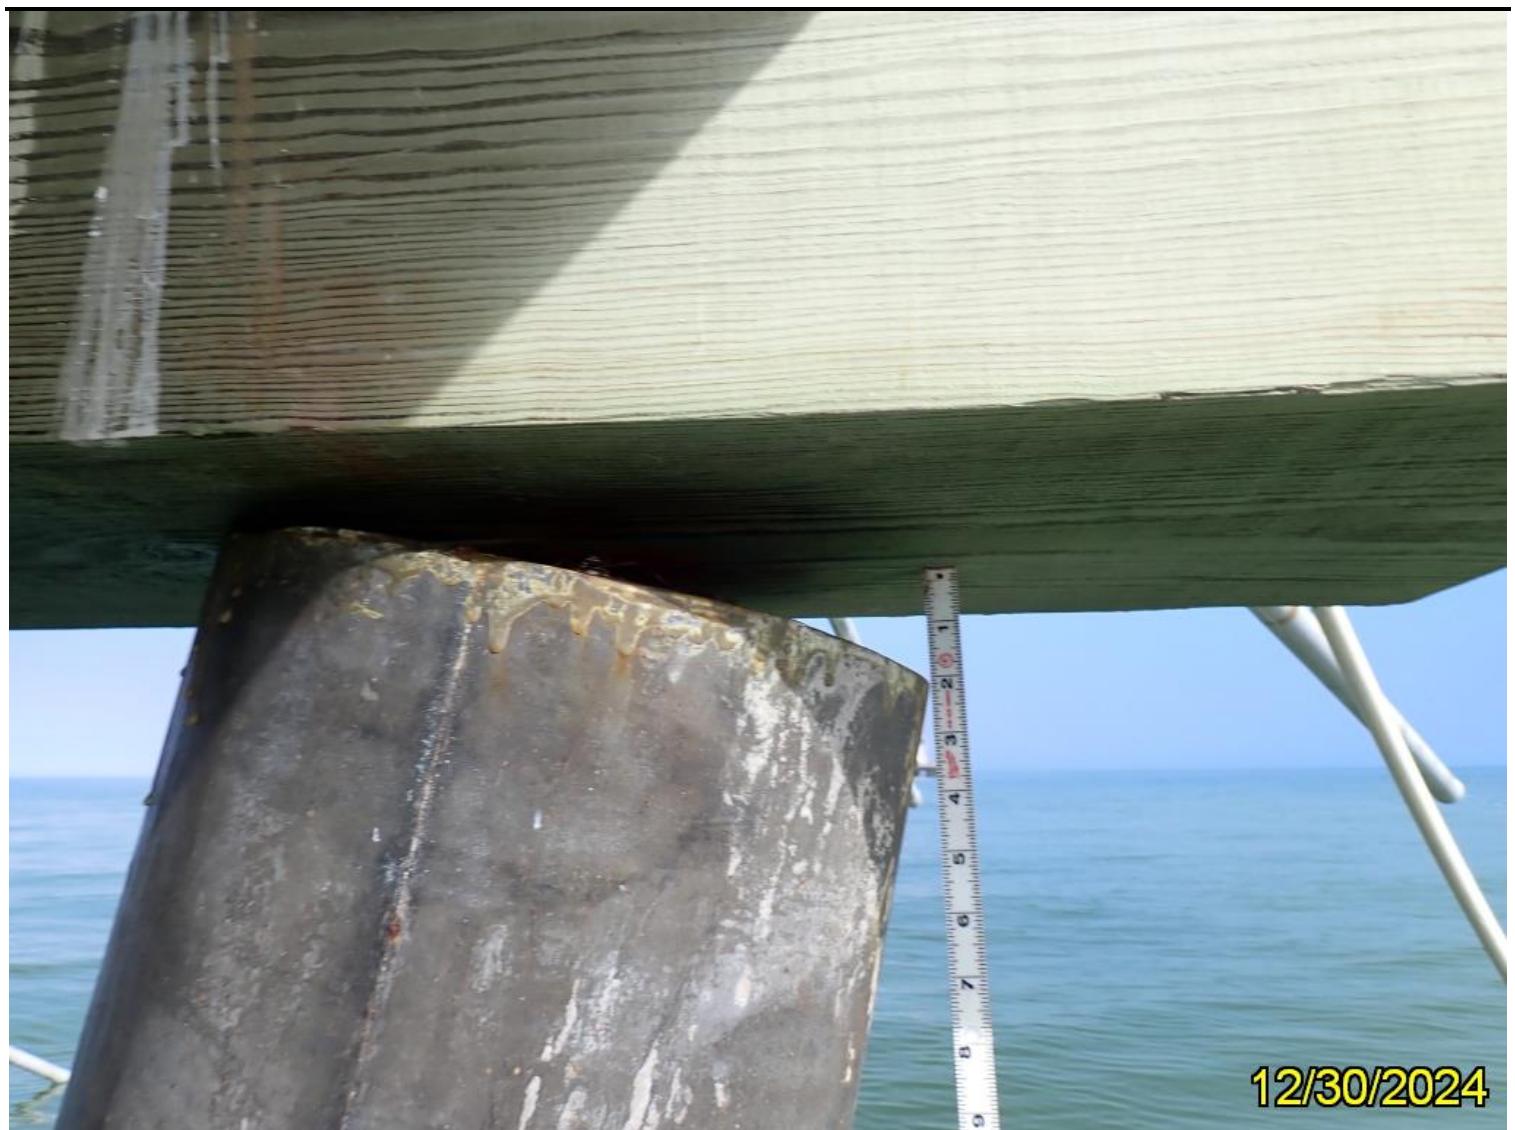
**Photo 17: Element 227 Re Conc Pile**

CS4 4000 = Pile 21-2 has settled and is leaning towards the east causing gaps along the east quadrant up to 2-1/4in. high resulting in 95% loss of bearing, due to the piles leaning the deck in Span 20 has shifted towards the east up to 1/2in. – NEW. Refer to Photos 17. (1EA)

Pile 21-2 leaning towards the east causing a gap along the east quadrant

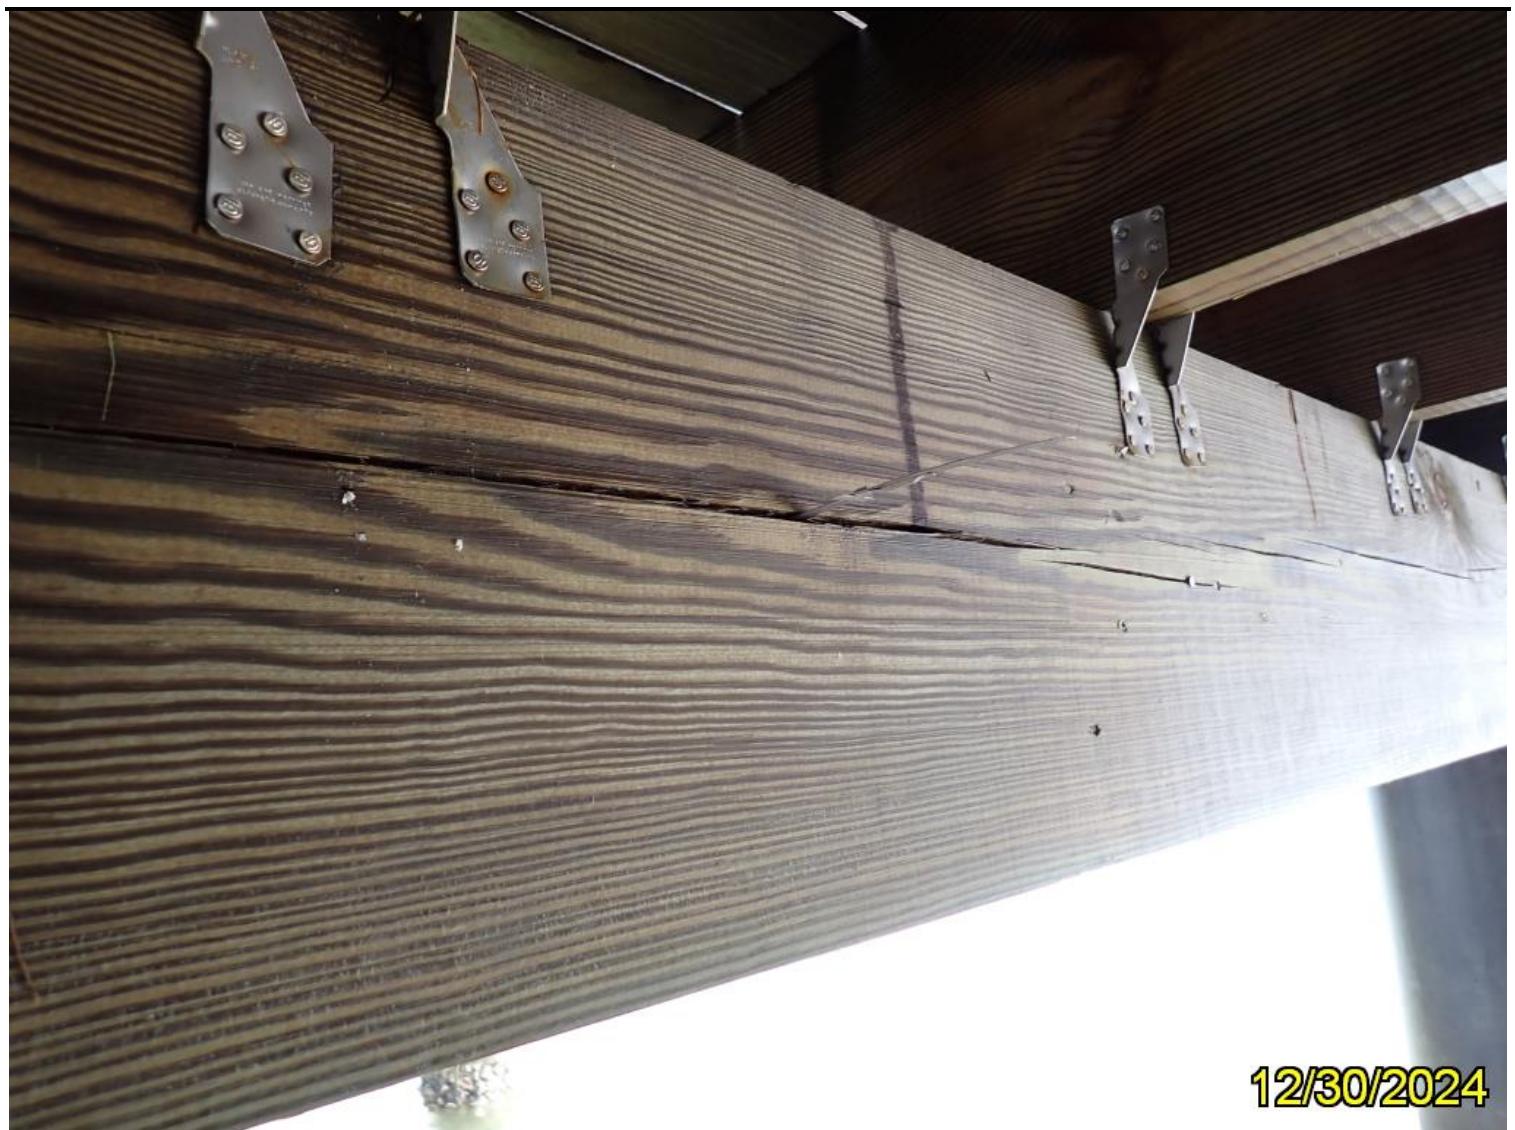
**Photo 18: Element 235 Timber Pier Cap**

CS2 1150 = Bent 5 has checks up to 3/16in. wide x up to 1-1/2in. deep in the south face – NEW. Refer to Photo 18. (12FT)

Bent 5 check in the south face

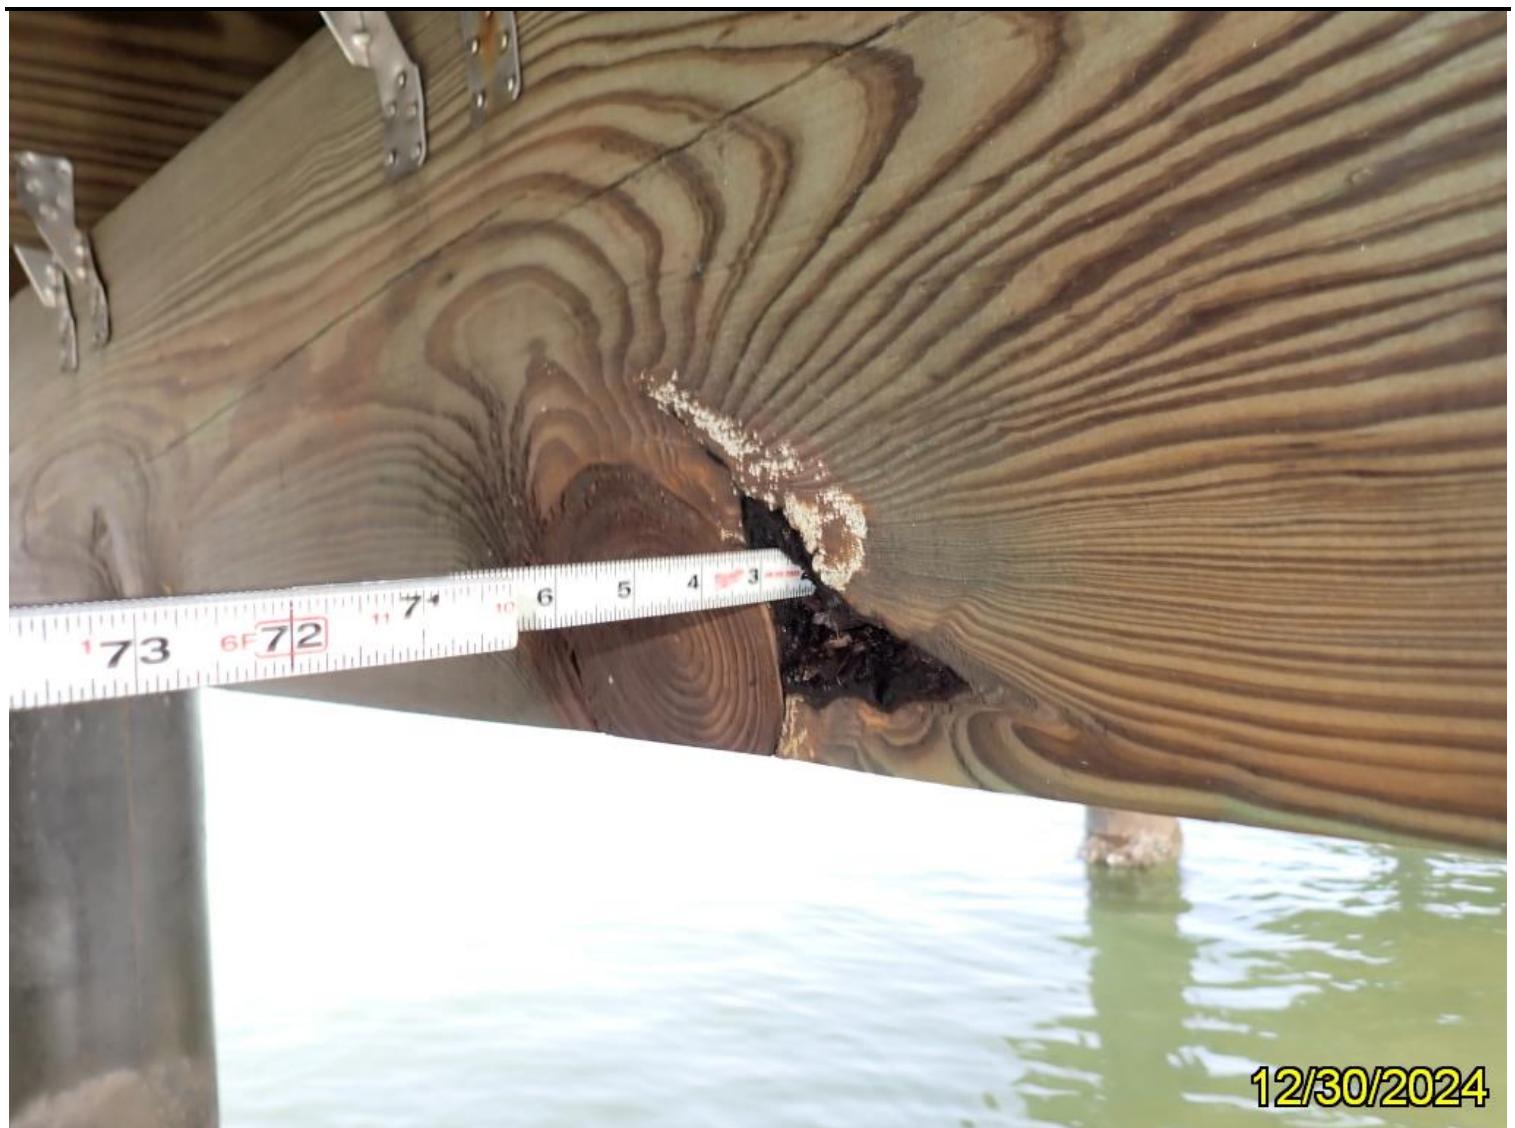
**Photo 19: Element 235 Timber Pier Cap**

CS3 1140 = Bent 9 south face has three knots that have moderate decay up to 7in. x 4in. x 3in. deep, north face has two – NEW. Refer to Photo 19. (5FT)

Bent 9 cap knot area of decay in the south face

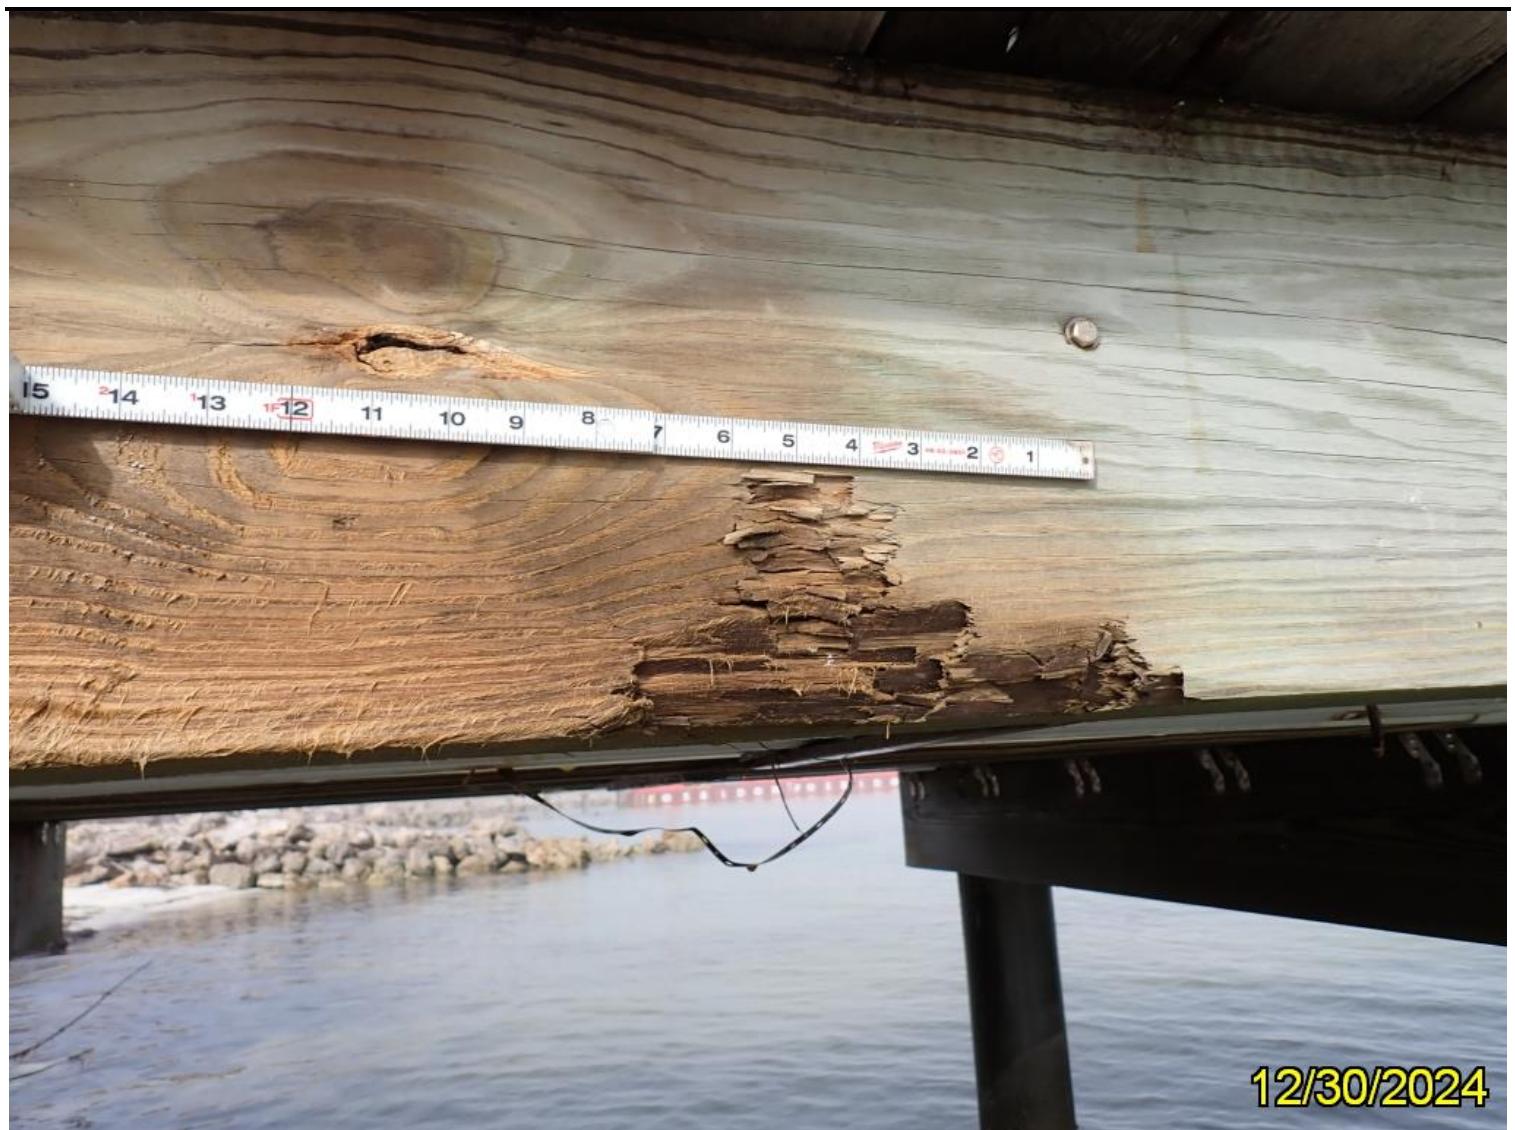
**Photo 20: Element 111 Timber Open Girder**

CS3 1150 = Stringer 4-7 has a 9in. x 4in. x 3/4in. area of shake in the bottom east face at mid span – NEW. Refer to Photo 20. (1FT)

Stringer 4-7 area of shake in the bottom east face at midspan

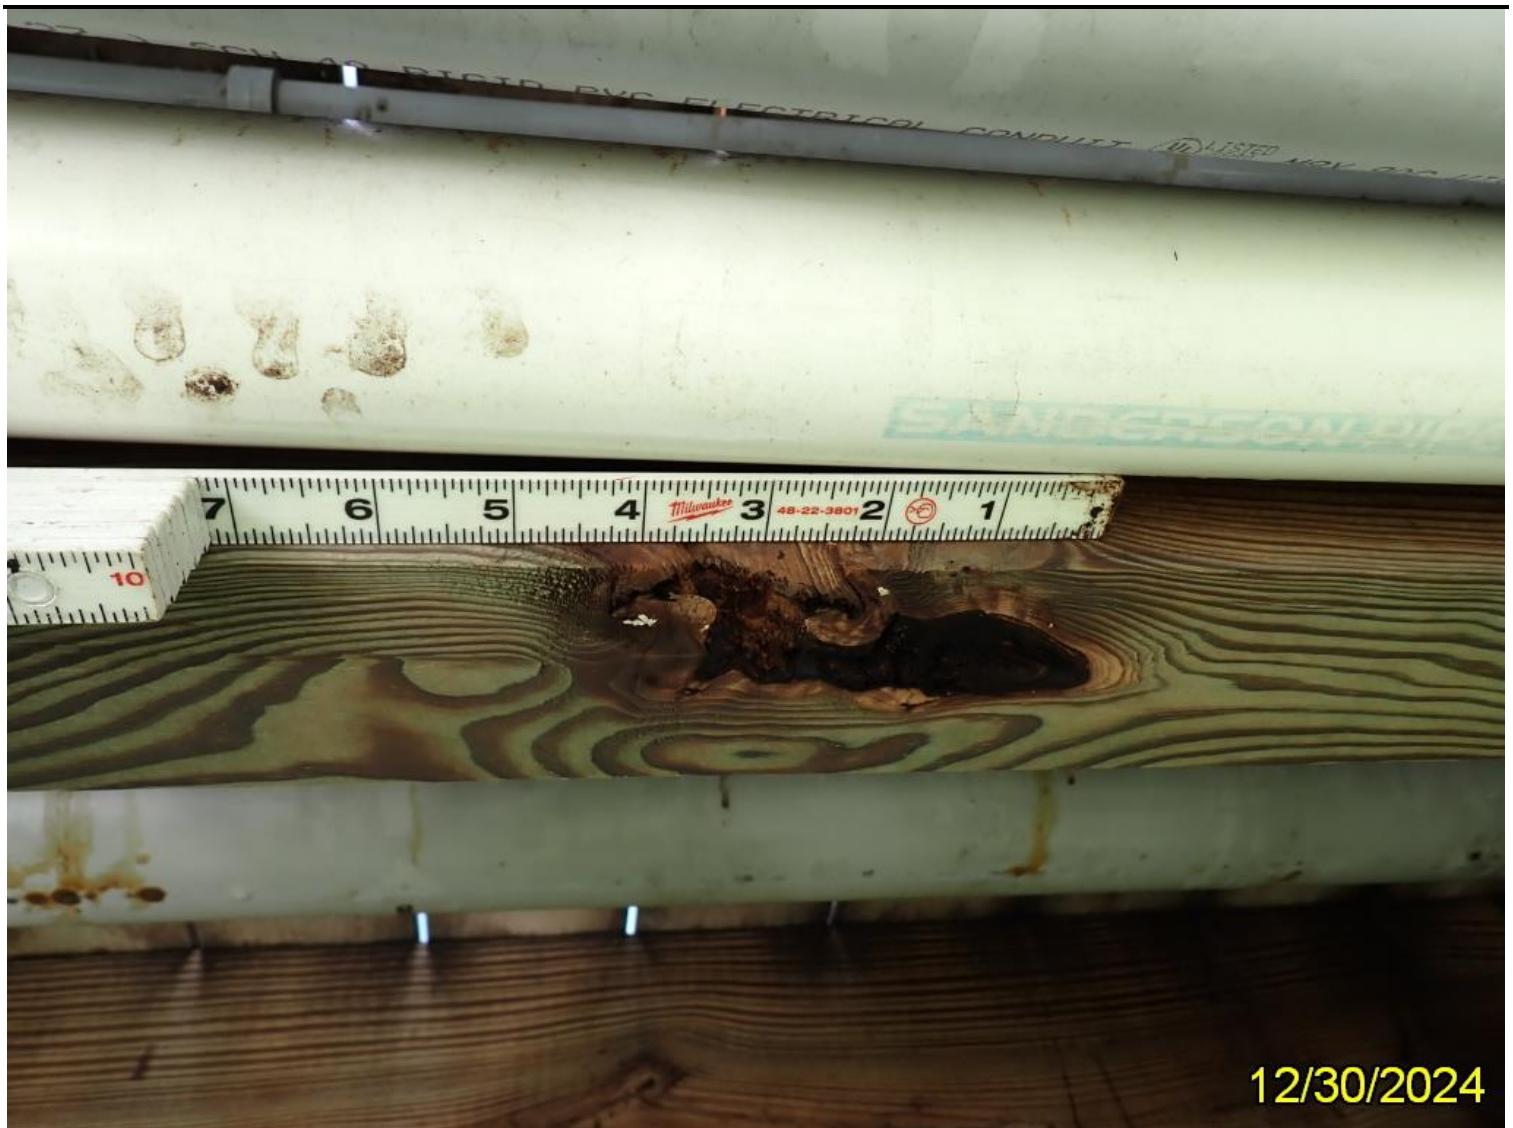
Photo 21: Element 111 Timber Open Girder

CS2 1140 = Stringer 10-6 has a 4-1/4in. x 1-1/2in. x 1/4in. area of decay at the knot, 18in. from Bent 11 cap – NEW. Refer to Photo 21. (1FT)

Stringer 10-6 area of decay at the knot, 18in. from Bent 11 cap

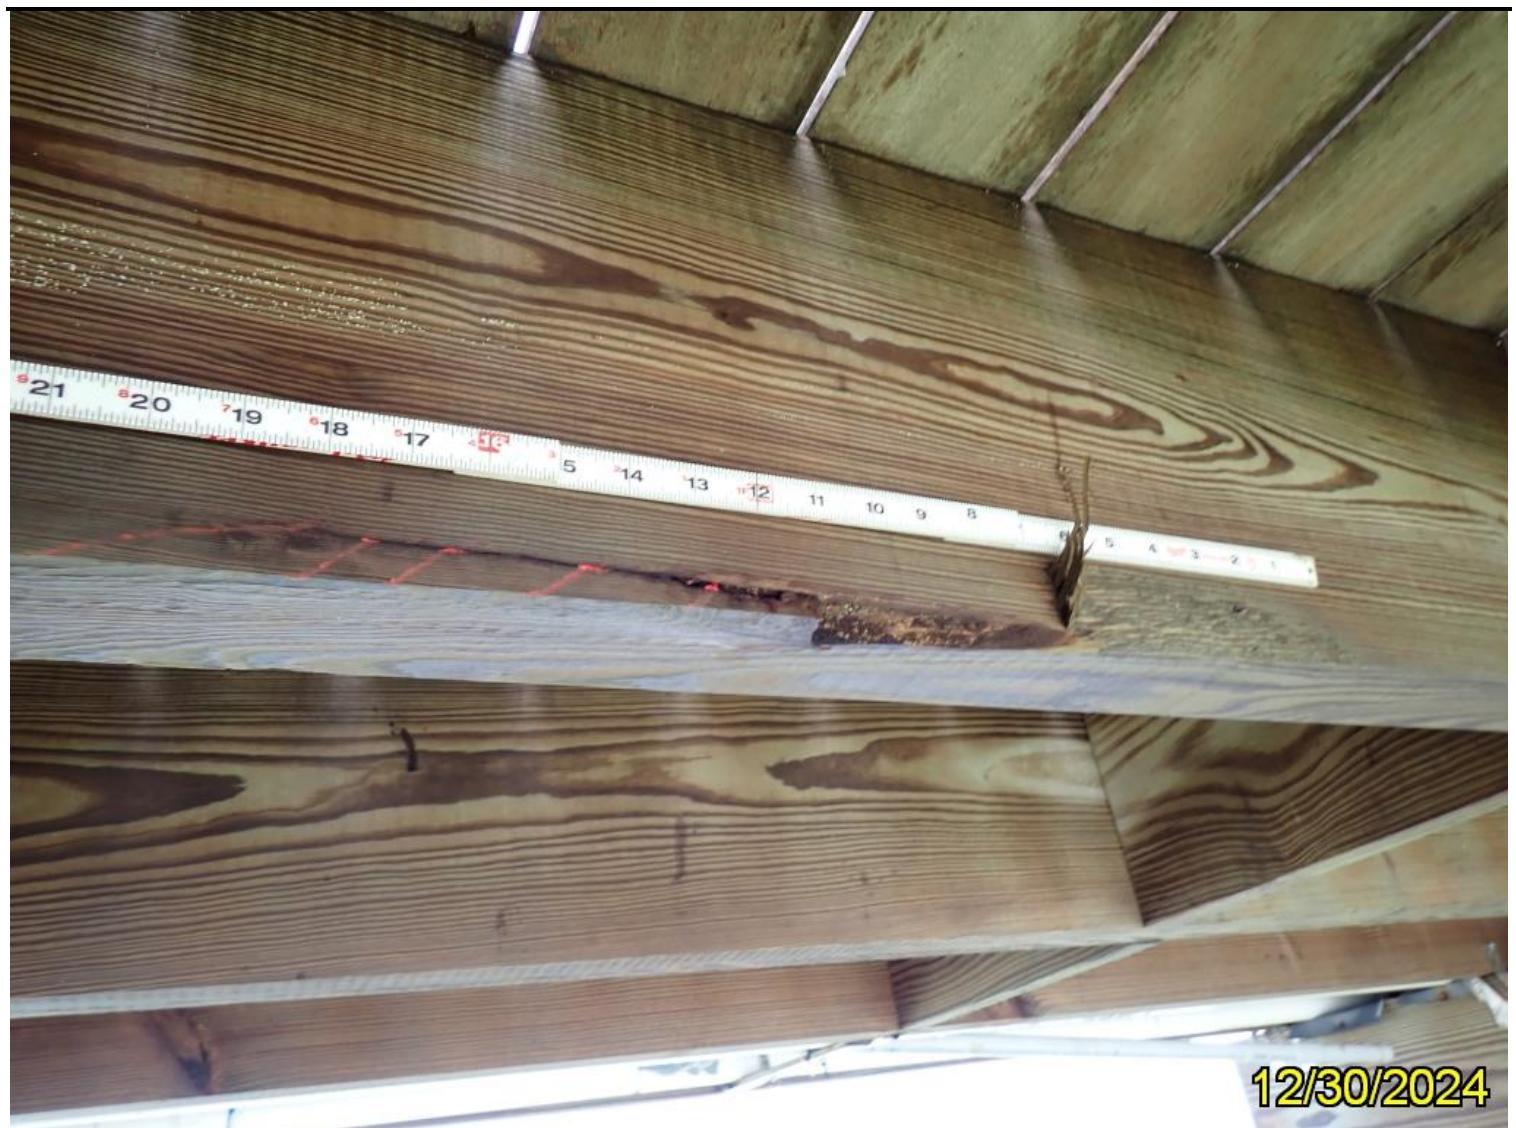
**Photo 22: Element 111 Timber Open Girder**

CS3 1170 = Stringer 11-4 has a 22in. x 2-1/2in. x 1/4in. splinter in the bottom east edge, 16in. from Bent 11 cap – NEW. Refer to Photo 22. (2FT)

Stringer 11-4 splinter in the bottom east edge, 16in. from Bent 11 cap

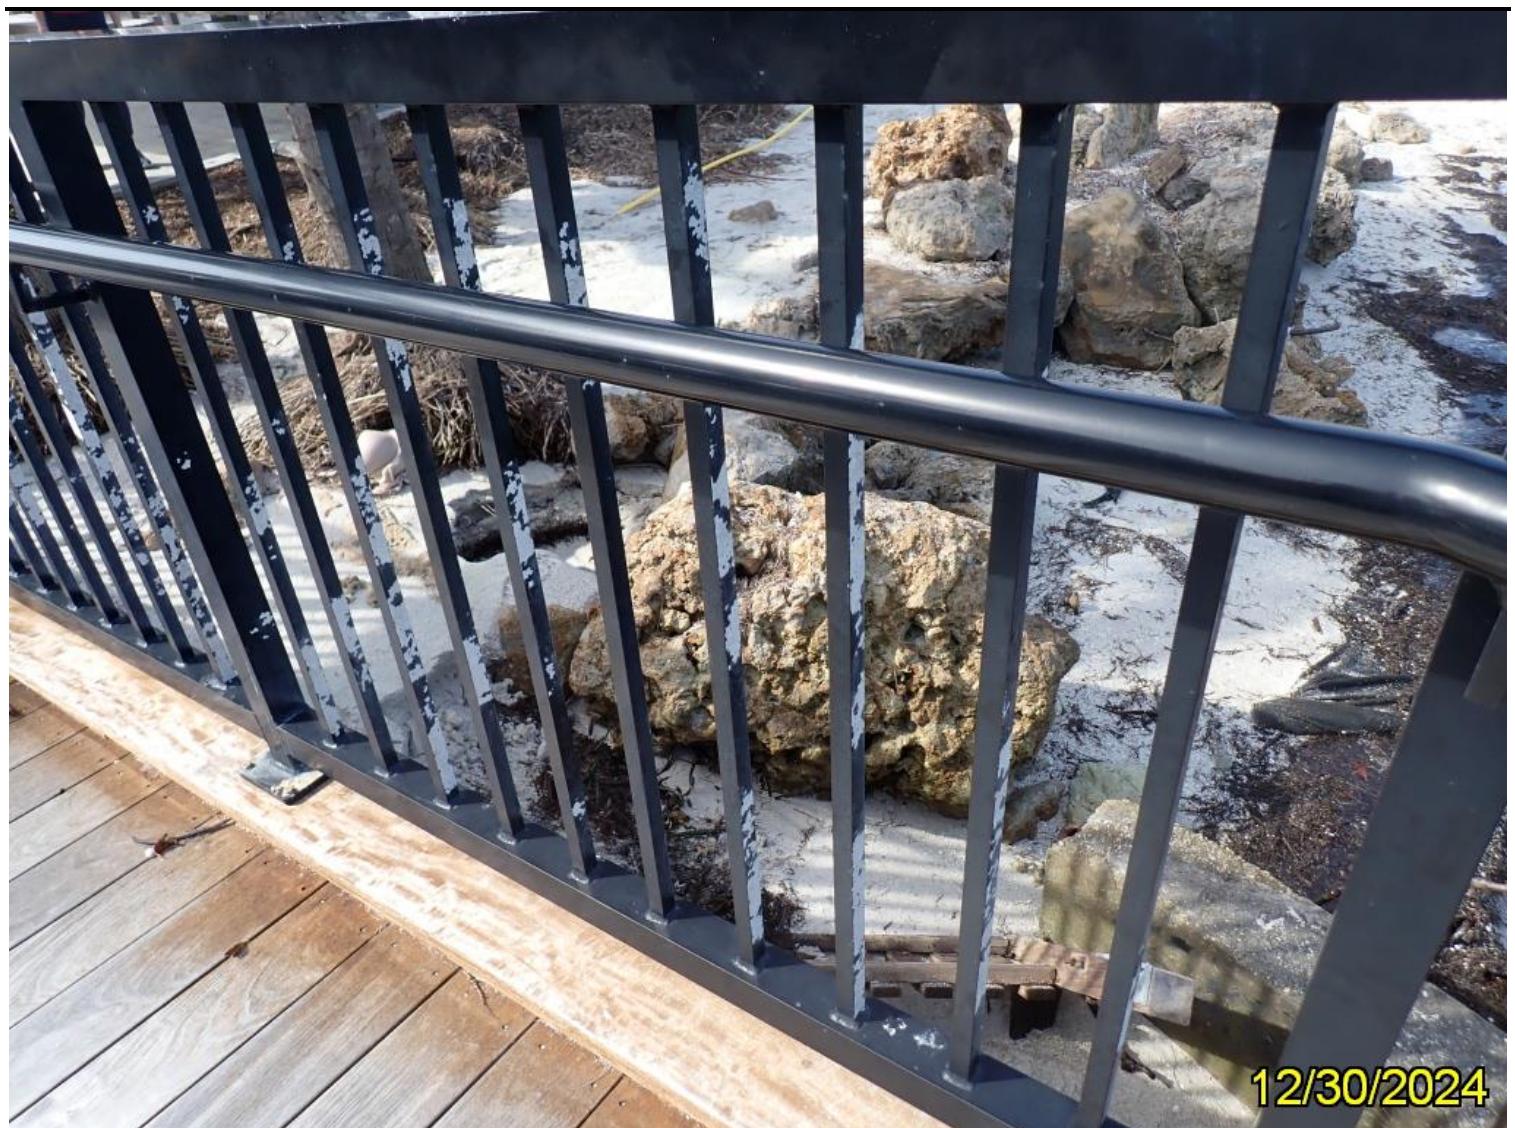
**Photo 23: Element 333 Other Bridge Railing**

The paint system has areas of missing paint intermittently throughout – NEW. Refer to Photo 23.

Typical area of missing paint system intermittently throughout the bridge rails

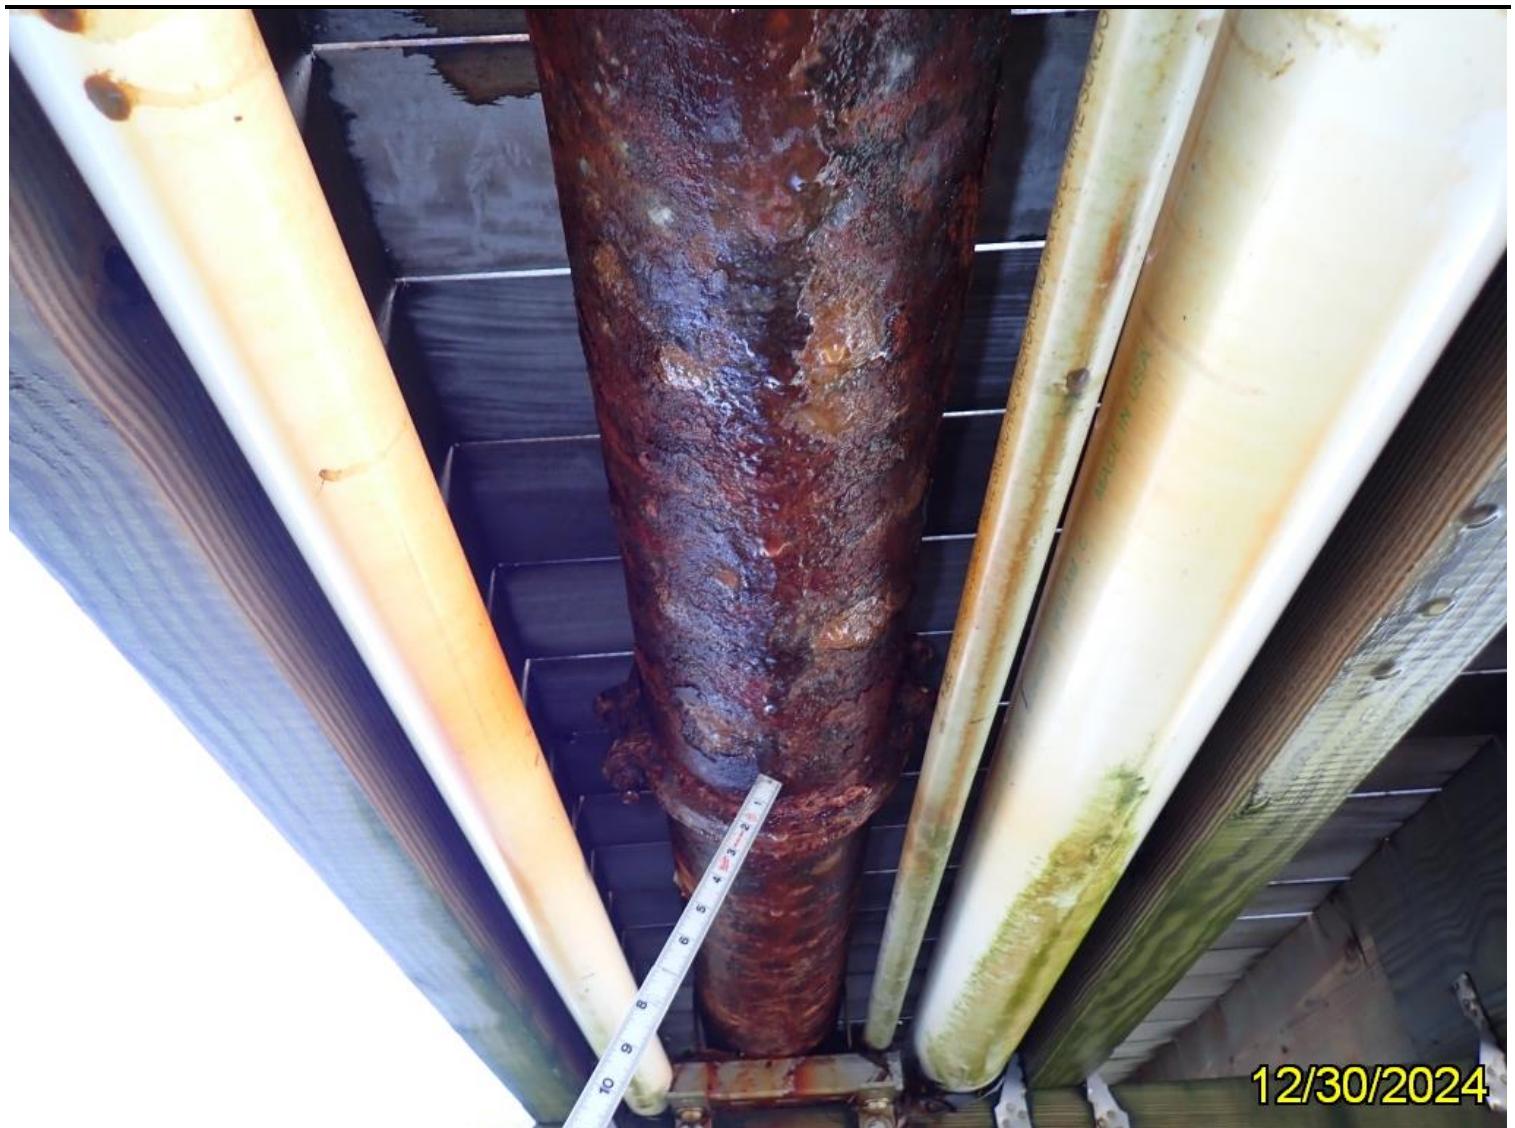
**Photo 24: Inspection Notes**

The steel Utility line in Bay 1 has moderate to heavy surface corrosion - NEW. Refer to Photo 24.

Bay 1 steel utility line moderate to heavy surface corrosion

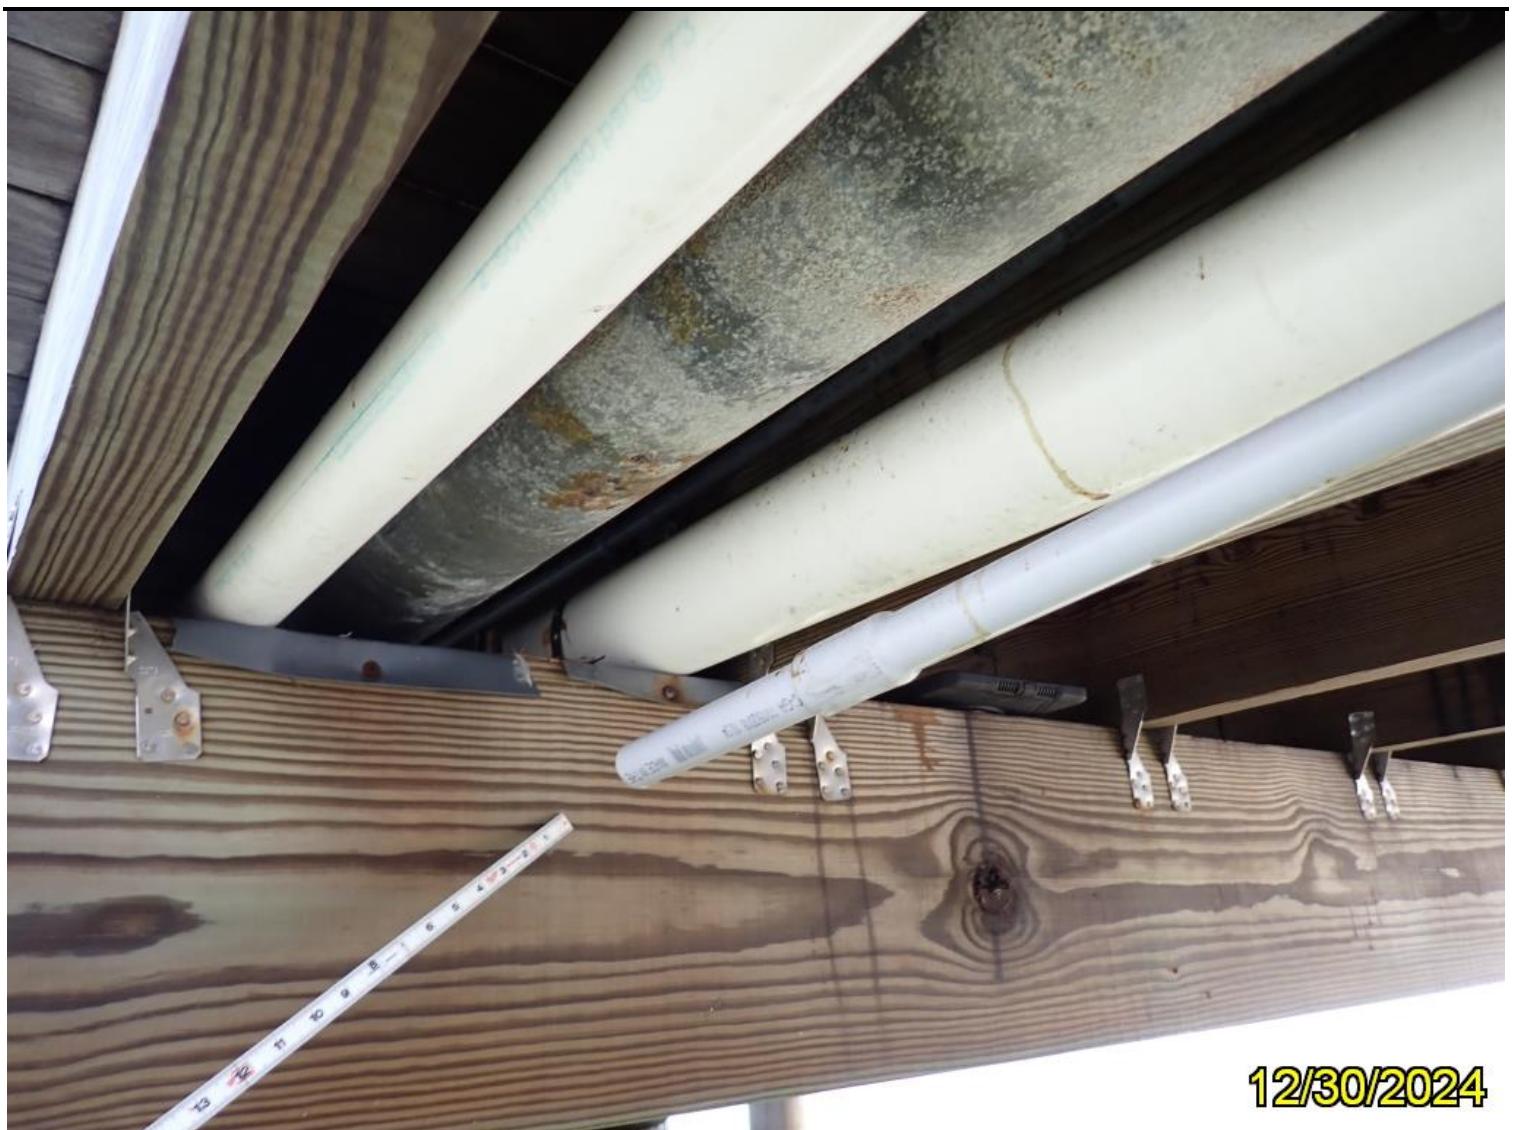
**Photo 25: Inspection Notes**

Bay 11-1 has a disconnected PVC utility line – NEW. Refer to Photo 25.

Bay 11-1 disconnected PVC utility line
