**ANNA MARIA ISLAND  
Inspection Report  
Inspection**

**Structure ID: Anna Maria Island City Pier  
DISTRICT: D1 - Bartow**

**INSPECTION DATE: 12/30/2024**

TYPE OF INSPECTION: Regular NBI

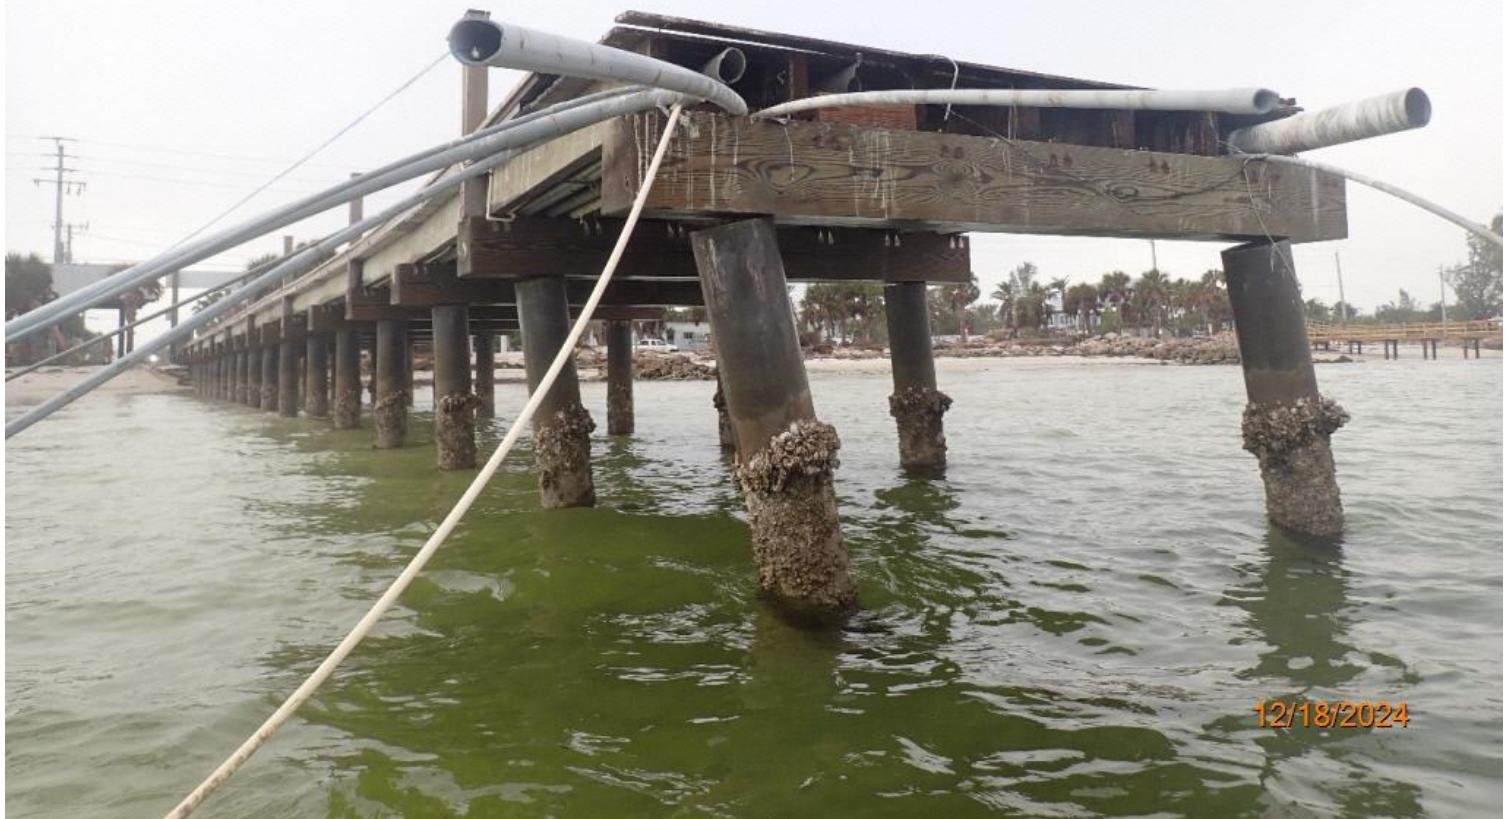
**Photo 26: Inspection Notes**

There are eight utility lines hanging off the end of the pier at Bent 21 and ten hanging off the south end of the bait and tackle building section - NEW. Refer to Photos 26 and 27.

Overview of utility lines hanging off the end of the pier at Bent 21

Remove disconnected utility lines hanging off the pier at bent 21 and at the south end of the bait and tackle section.

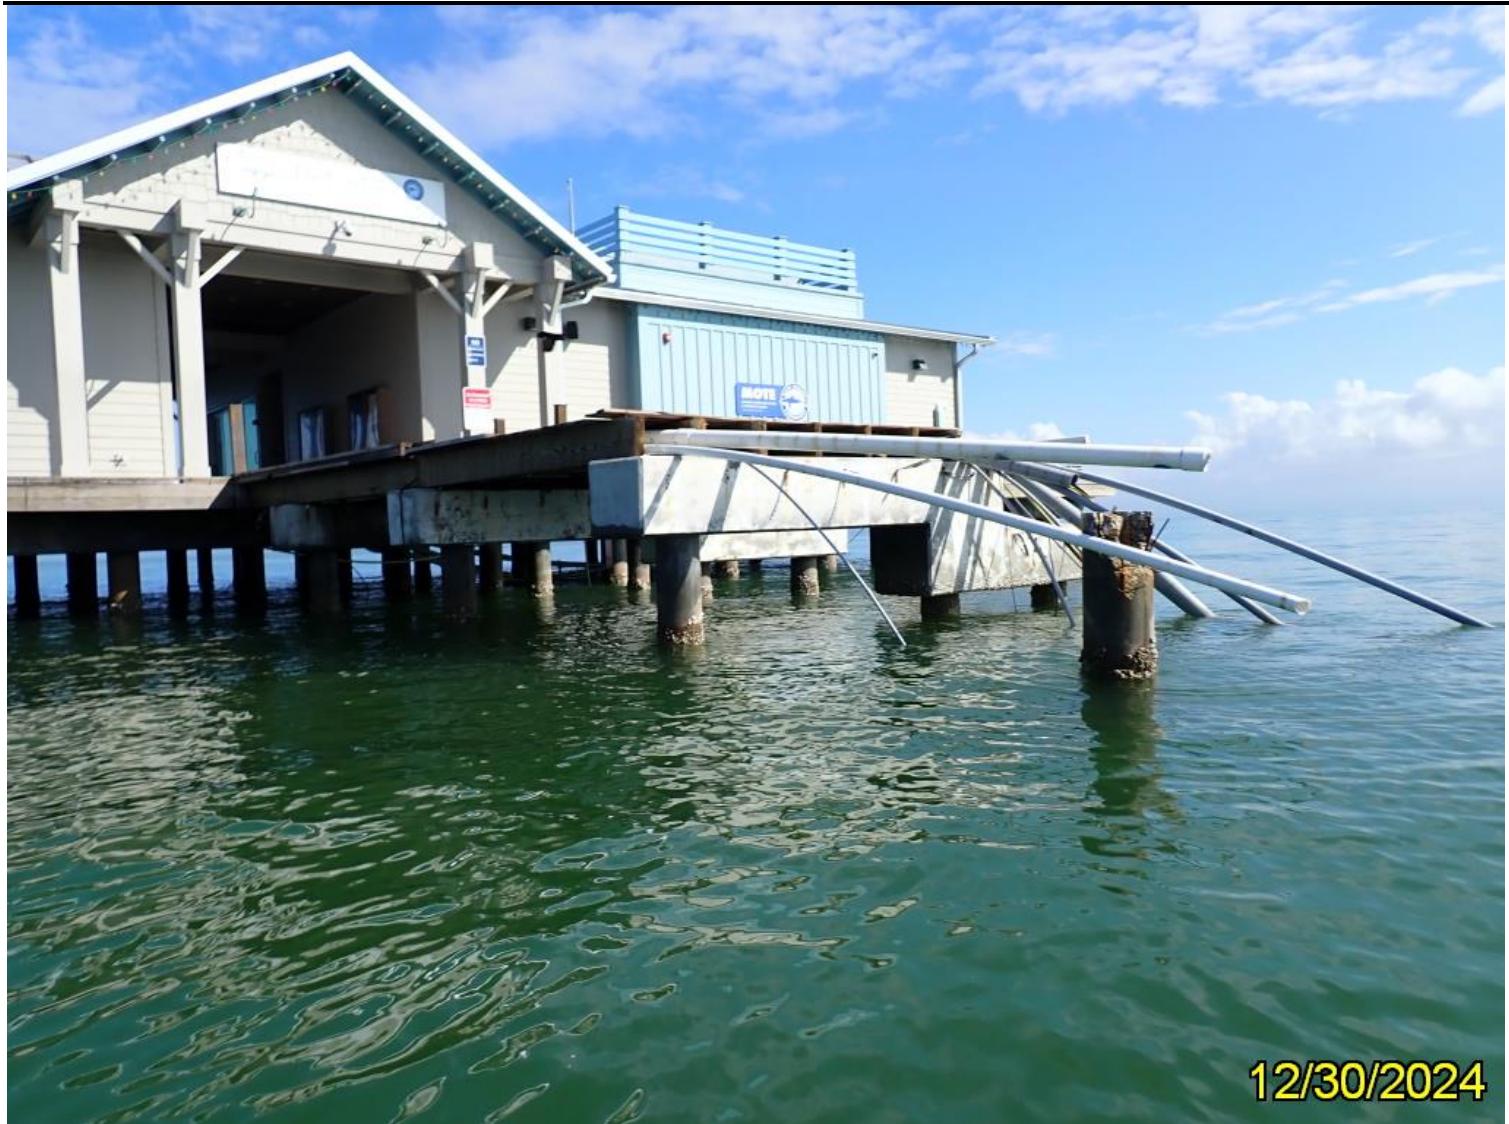
**Photo 27: Inspection Notes**

Overview of utility lines hanging off the south end of the bait and tackle section

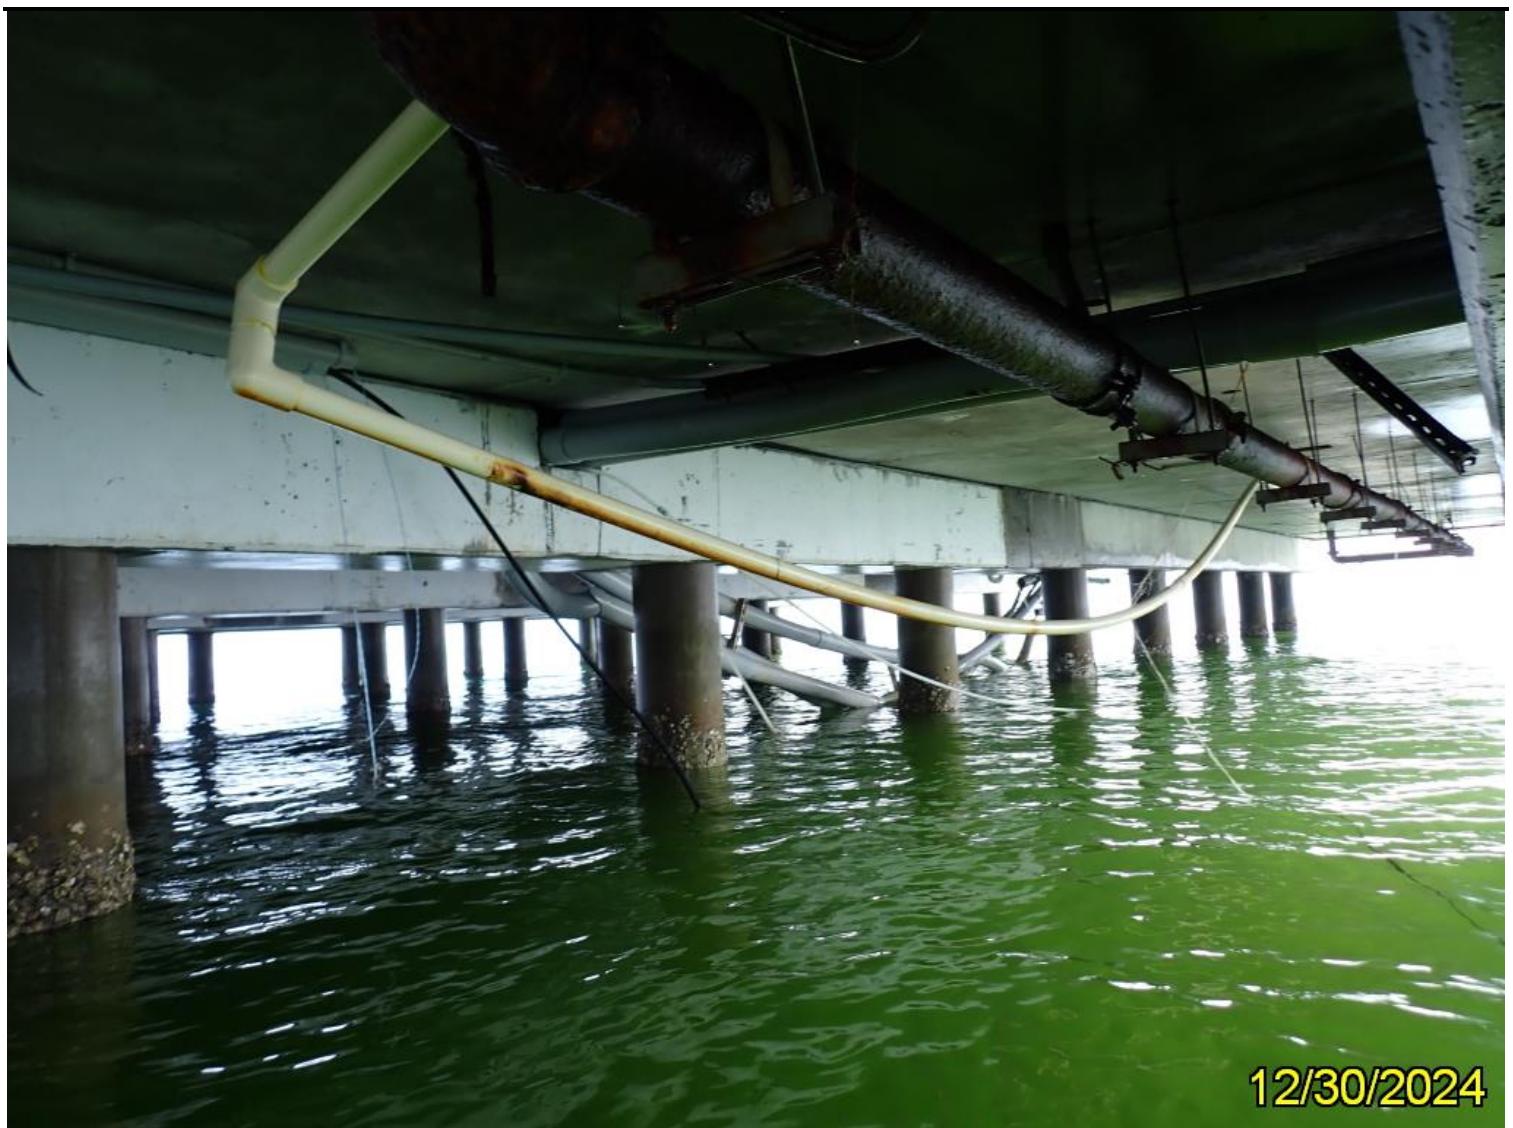
**Photo 28: Inspection Notes**

The utility lines under the bait and tackle building section have areas of heavy sagging causing the lines to sag into the water - NEW. Refer to Photo 28.

Overview of utility lines sagging under the bait and tackle building

Reset utility lines under the bait and tackle building to the correct position.
