Presented by  
Joe Foster @ 3-5-25  
CJPC mtg

### Elevation Analysis:

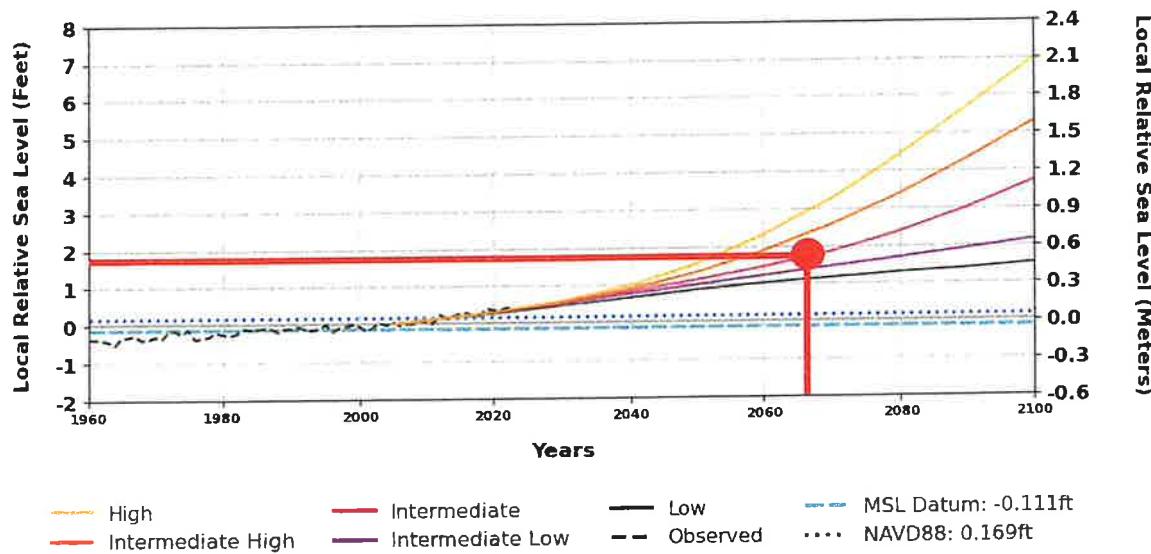
**Annual Relative Sea Level Since 1960 and Projections  
8726520 St. Petersburg**

The current seawall elevation in the community is mostly around +2.3' NAVD (North American Vertical Datum). This is approximately 2' above the Mean High Water Level (per NOAA). NOAA projections indicate that sea levels will rise approximately 2' by the year 2065.

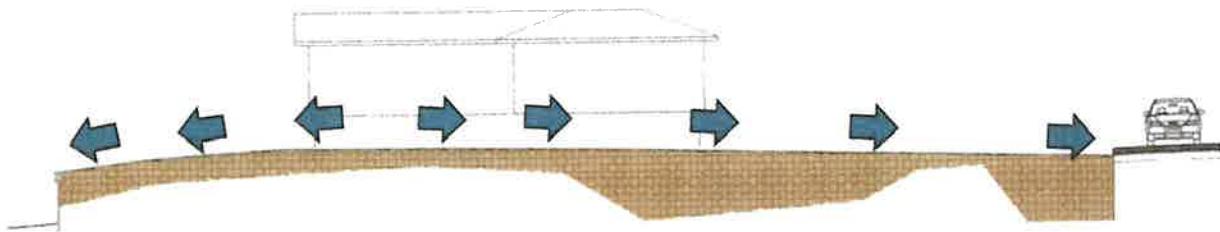
Current Conditions

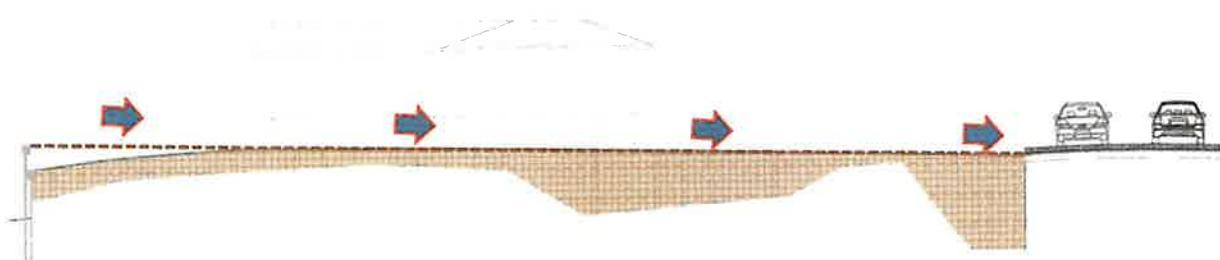
Cap Elevation Raised Above Crown of Lot  
(NOT RECOMMENDED)

With the understanding that this wall will be past its useful by then, it is recommended that any new seawalls that are installed should account for this projected sea level rise. Just recently, the Town of Longboat Key has updated the seawall code to allow for the elevation of the seawall caps to be raised up to +6.0' NAVD. With this said, the existing stormwater system needs to be accounted for when increasing the seawall cap elevation. Currently, the typical drainage plan for each lot has the stormwater shedding half to the seawall and half to the roadway. If the seawalls are raised too high, then all the stormwater would shed to the street, overwhelming the stormwater system.

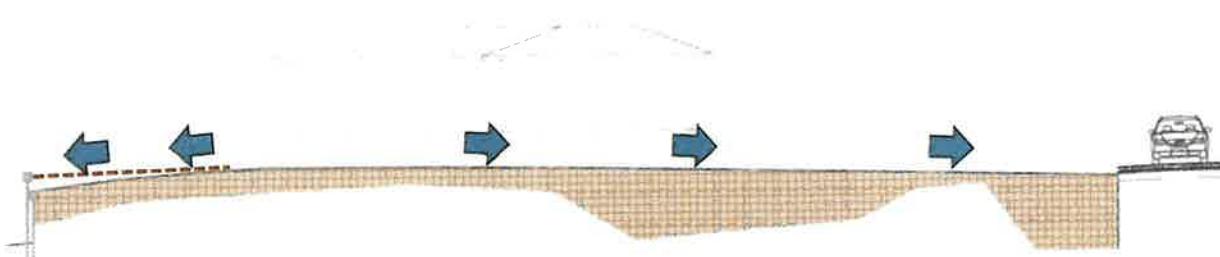
Cap Elevation Raised

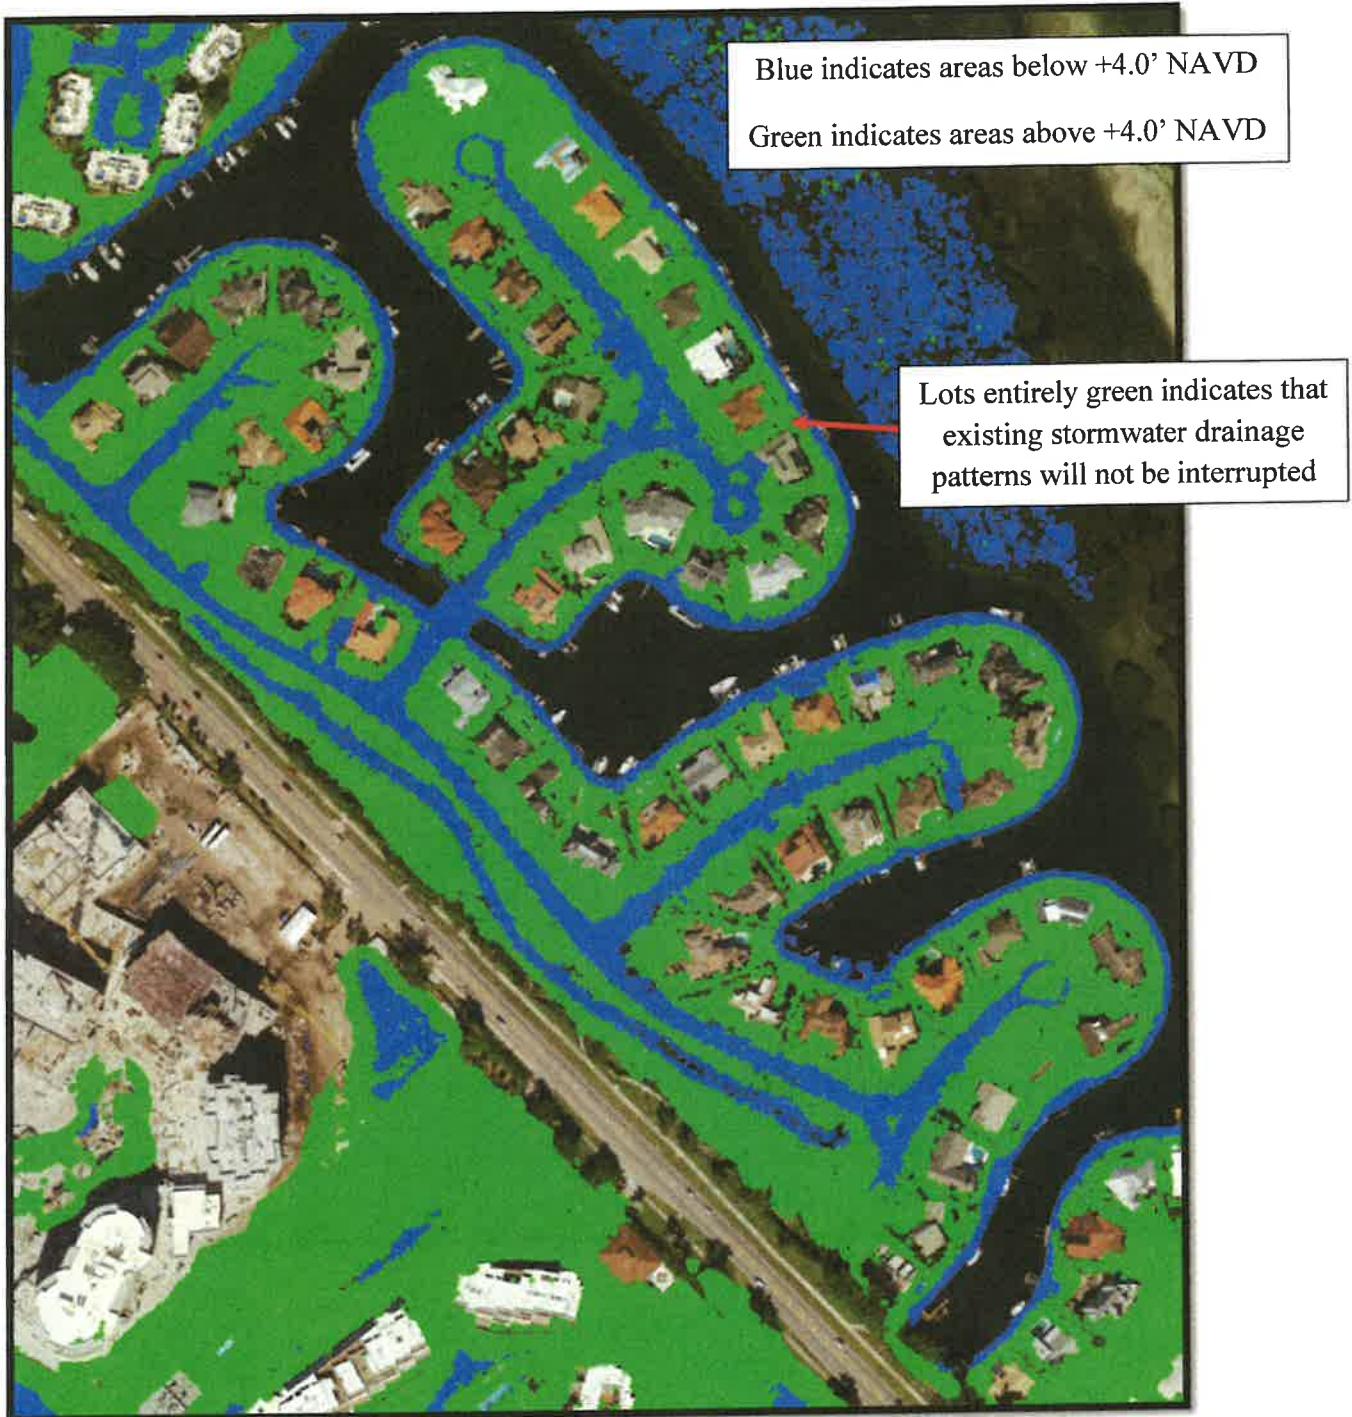
Cap Elevation of +4.0' NAVD

Pros – Uninterrupted drainage profile

Cons – Minimal resiliency against future sea level rise

In order to determine which seawall cap elevation would NOT shed more stormwater to the street, but raise the walls as much as possible to combat sea level, the following maps were examined:

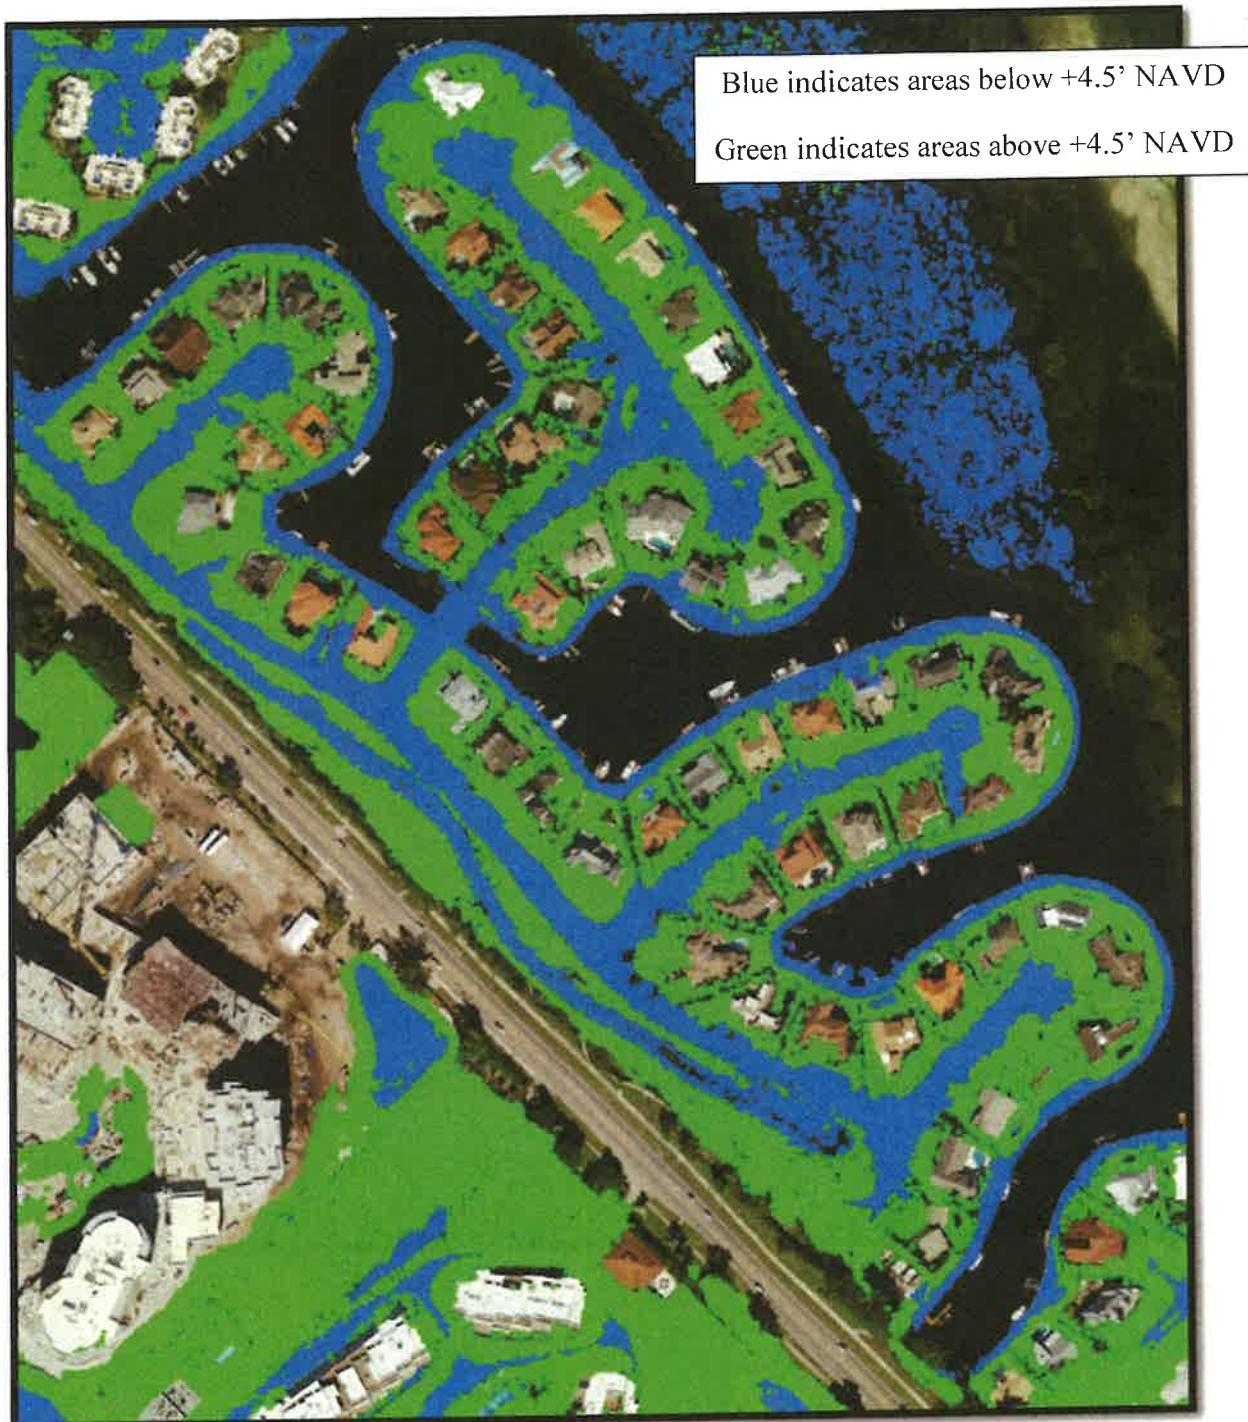
Cap Elevation of +4.5' NAVD

Pros – Uninterrupted drainage profile, adequate resiliency against future sea level rise

Lots entirely blue indicate the seawall would extend above the crown of the lot, and the lot would need to be regraded

Blue indicates areas below +5.0' NAVD

Green indicates areas above +5.0' NAVD

Blue between houses indicates drainage patterns will be interrupted and will need modification

The recommended cap elevation is +4.5' NAVD. This elevation provides additional resiliency to the property without significantly altering the community's stormwater drainage. Raising the elevation to the maximum allowed elevation (+6.0' NAVD) will create more resiliency, but it would cause adverse effects to the stormwater system in the community. The raise will help extend the life of the seawall as the reinforced cap will be higher in elevation and not be exposed to saltwater when compared to a cap at a lower elevation. This raise of approximately 2.2' be greater than the predicted 2.0' of sea level rise which adds additional resiliency.

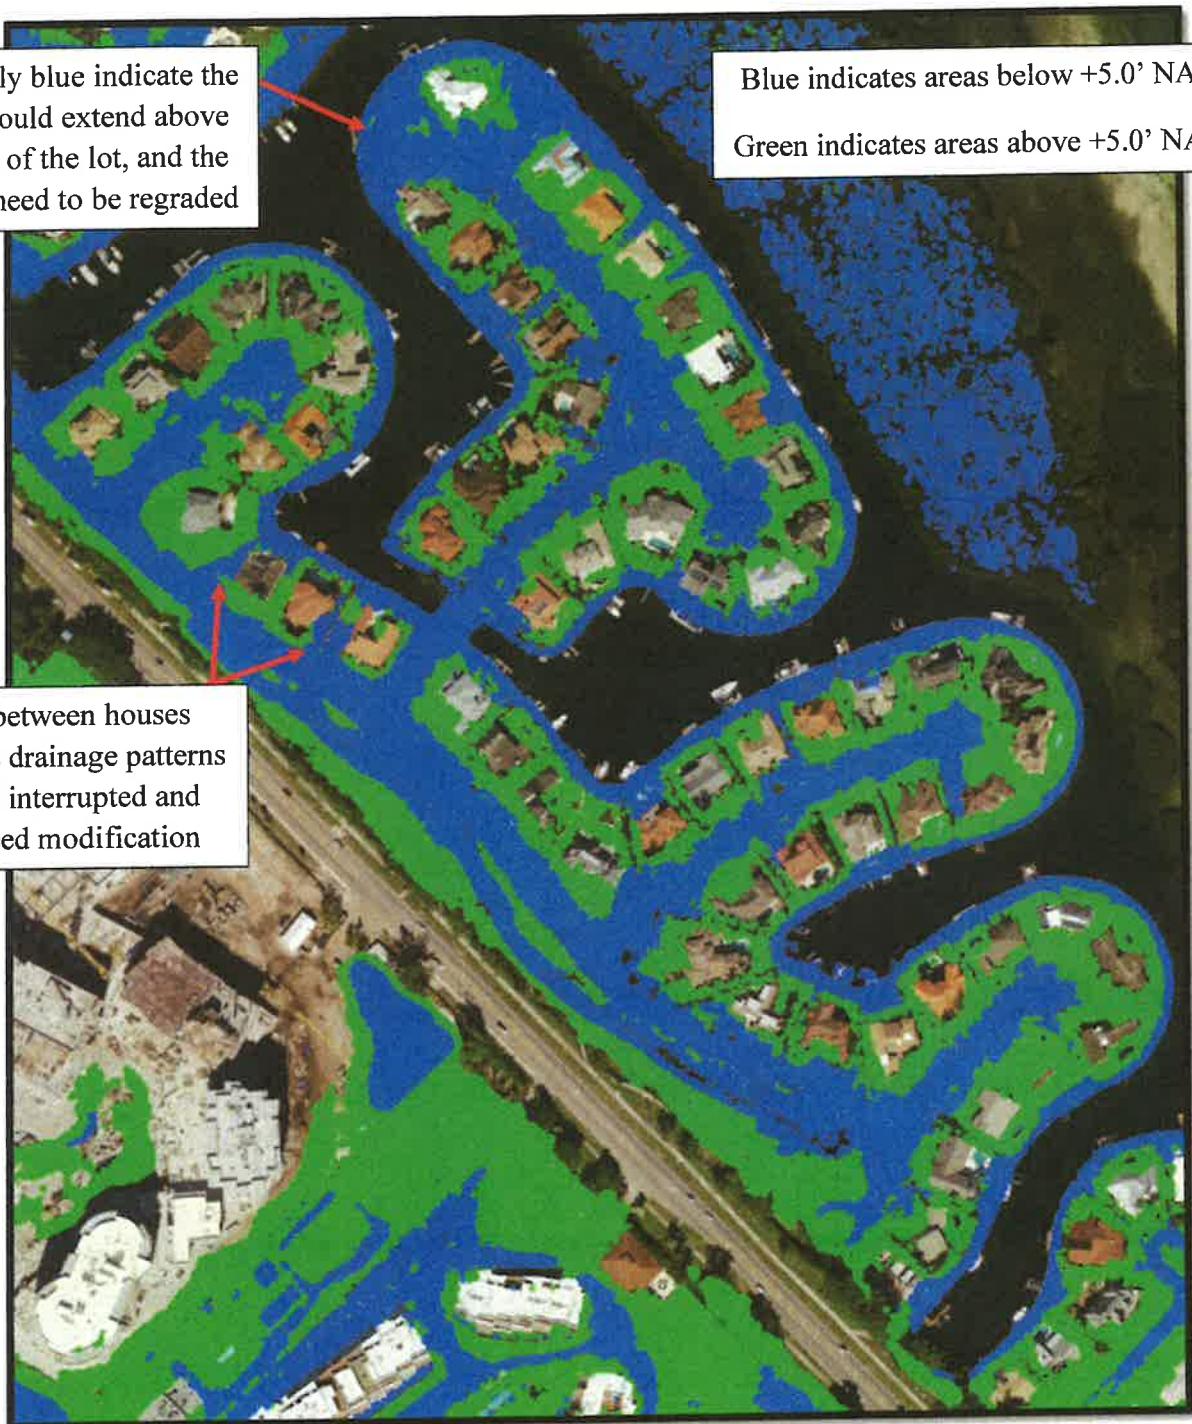
#### Cap Elevation of +5.0' NAVD

Pros – Additional resiliency against future sea level rise

Cons – Interrupted drainage profile, multiple lots requiring alteration/regrading

A cap elevation of +5.0' NAVD was analyzed, and while it generally maintained proper stormwater drainage (with the exception of a handful of lots which may be addressed with French drains), it was found that backfilling the lots to match the cap elevation would require demolishing/rebuilding the patios/pool decks at a number of homes along the seawall.

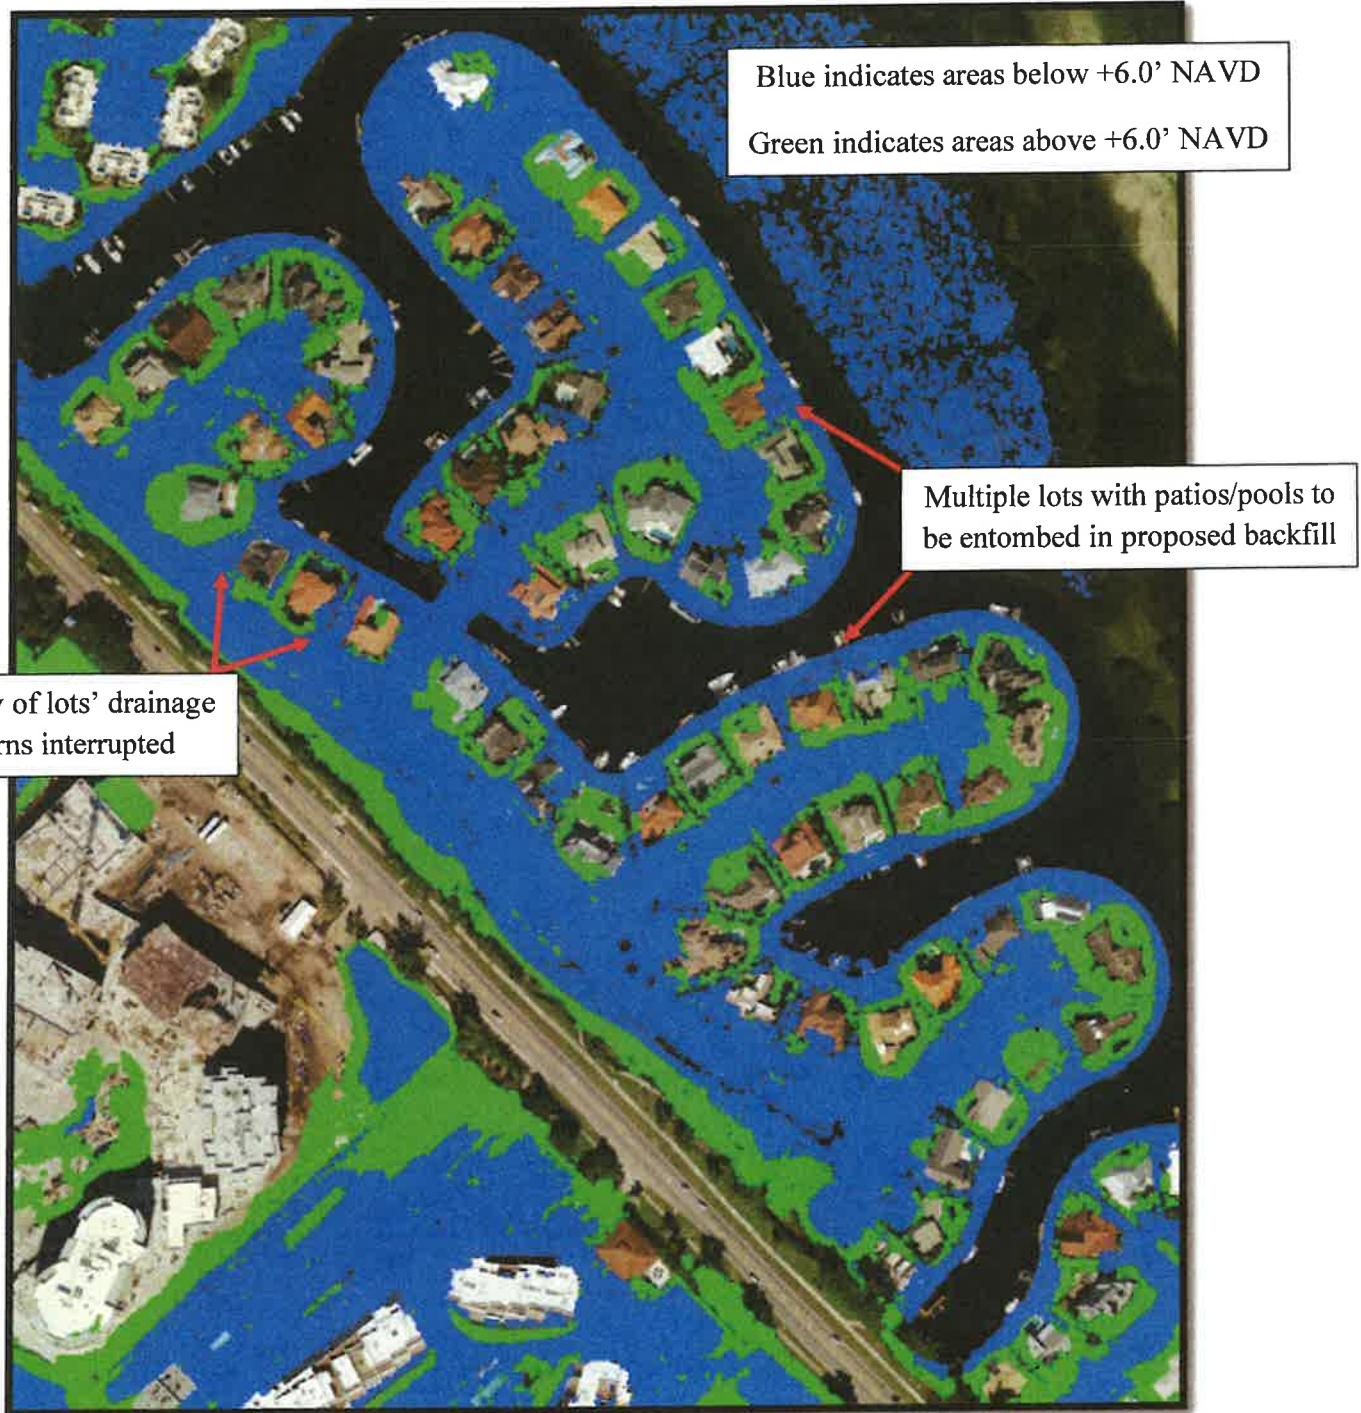
Cap Elevation of +6.0' NAVD

Pros – Additional resiliency against future sea level rise

Cons – Significantly interrupted drainage profile, multiple lots requiring alteration/regrading, significant impacts to pools

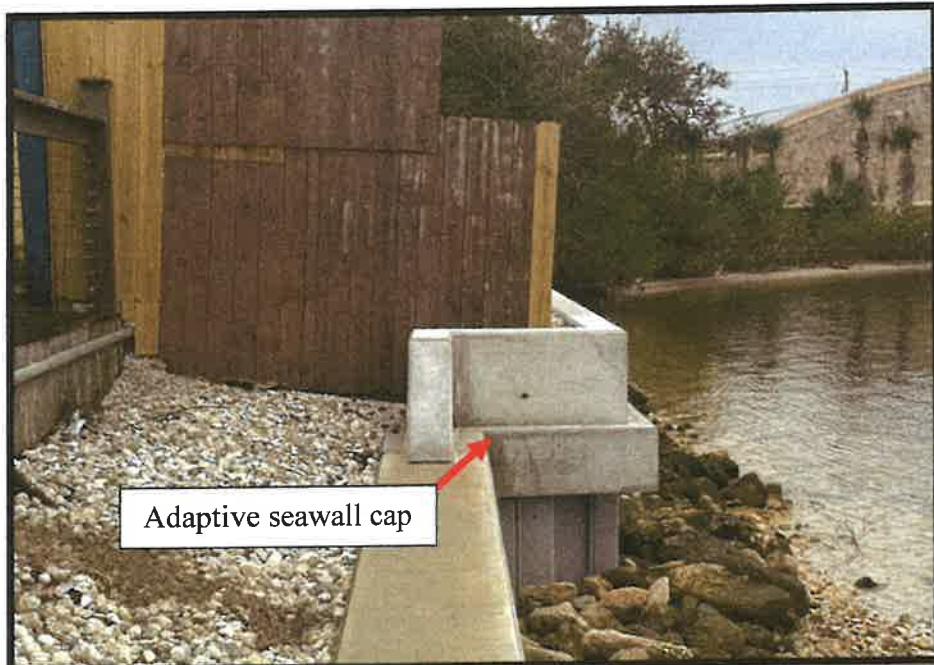
If desired, the new seawall could be designed with an adaptive cap, meaning the seawall would be designed to accommodate a stem wall to be poured on top of the seawall cap in the future. This would allow the seawall to be raised if the redevelopment was more conducive for higher cap elevation.
